**E K O Akowuah**
**Experiences and lessons from the operation of Monrovia sewerage system**
**INTRODUCTION**

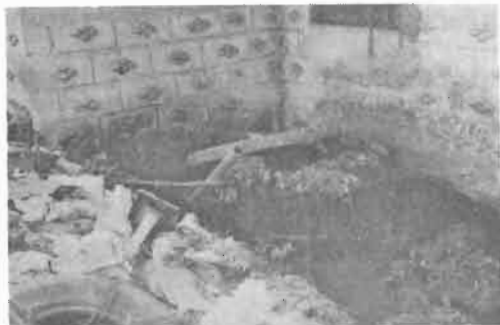
- (i) Chronic lack of maintenance action for the removal of grit and sand from sewers: The maintenance crews had never been equipped with tools for sand removal and therefore sand had continued to accumulate in the sewers throughout the 30 years history of the system.

Figure 1. Raw sewage spilling from a manhole forms a rivulet running to an open drain in the Sonnewein sector of Monrovia. The manhole is on a sewer permanently blocked by sand and grit.

- (i) A sewer-cleaning truck with equipment for water-jetting and vacuum-suction was purchased to be used to implement a programme for removing sand and grit from the sewer network. A team of operators was also trained to use the equipment.

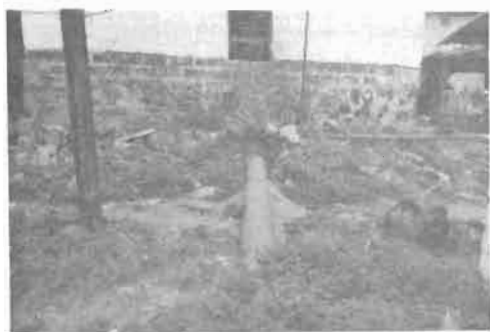
- (iii) Buildings constructed over sewers: Many of the sewers laid in 1952 had been laid through easements behind private properties and not in the streets. Because of very loose implementation of building control regulations it had been possible for developers to build on the sewers leading to structural collapse in several instances.

Figure 2. A house has been constructed directly on top of this concrete sewer pipe in the Sonnewein sector of Monrovia.

- (ii) The stretches of sewer most seriously affected by having buildings erected on them were taken out of service and replaced with new mains laid in the streets.
