Sustainability of hand-dug wells in Tanzania: results from a post-evaluation

L. Gill, & F. Flachenberg (Ireland)

BRIEFING PAPER 2088

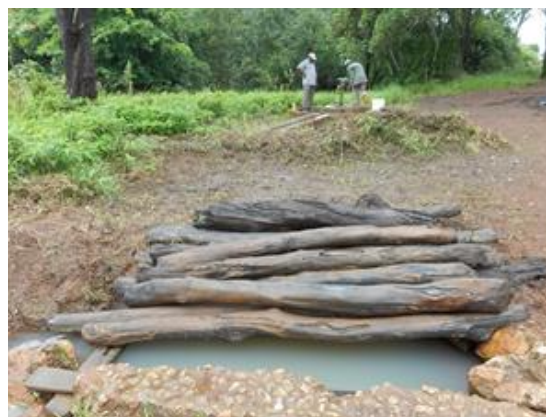
these shallow wells (see Photograph 2). In addition, many users reported significant problems with reduced yields in the dry season.

Photograph 2. Proximity of PE17 hand pump to traditional open water source
