39th WEDC International Conference, Kumasi, Ghana, 2016

**Performance of Iron removal plants on groundwater:
field assessment in Central Uganda**

REFEREED PAPER 2386

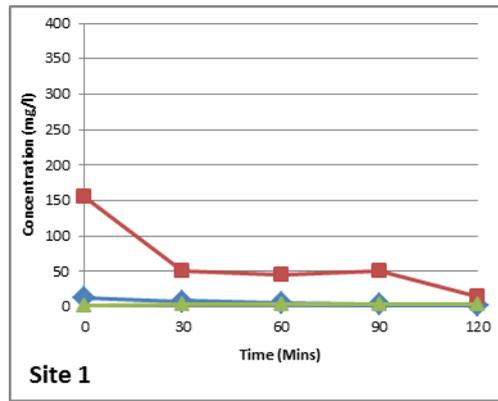
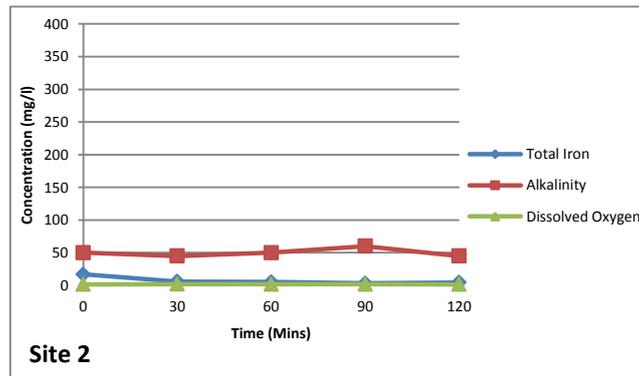
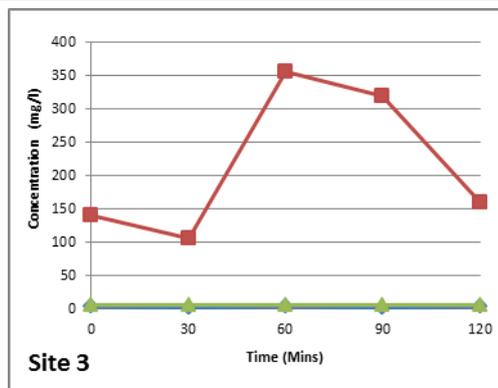
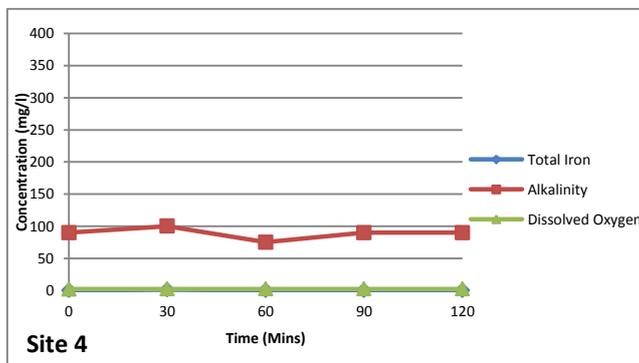
The study showed that the sampled boreholes are with pH levels (5.72 ± 0.15), typical of groundwater sources and not being too low ($\text{pH} < 3$) to be aggressive. Also the temperature variability between sampling times and also between the sources ($23.0 - 25.1^\circ\text{C}$) is not that much implying minimal impact from surficial or ambient conditions. The groundwater from the sampled boreholes is with relatively high levels of dissolved oxygen ($>2\text{mg/l}$) which renders it a fresh water source. The sampled boreholes are generally with a high pH buffering capacity as indicated by the high alkalinity levels ($>40\text{mg/l}$) (Figure 1) leading to resistance to significant pH change.

With regard to boreholes in Mpigi (Sites 1 & 2), there was a general decrease in pH, alkalinity and Total Iron with time. The quality of the water sampled out of the boreholes with time is indicative of the water flowing through the aquifer. However, it suffices to note that the quality variations are also dependent on the amounts of water pumped out of the aquifer prior to the sampling times. In Kamwenge, quality of the water in the borehole at Site 3 exhibited an increase in pH, dissolved oxygen and alkalinity with time. However, the Total Iron and alkalinity levels were with a decreasing and increasing trend most likely due to the quantities of water being pumped out of the aquifer prior to the sampling times. The borehole at Site 4 in Kamwenge (Not closed the previous night prior to the field measurements) illustrates that continuous pumping of the borehole resulted in improved quality of the water with time giving a better indication of the water quality within the aquifer. It suffices to note that in this particular borehole, the initial measured Total Iron levels were low compared to the rest of the boreholes which likely led to a decrease to undetected levels in the subsequent sampling times. Interviews with the operator also revealed that the down-hole-pump system of the borehole at Site 4 had been replaced with PVC pipes that explain the low levels of Total Iron concentration in this particular borehole.

The source at Site 3 in Kamwenge district showed low values of Total Iron concentration of 1.9 ± 0.38 , but high alkalinity during the two hours of continuous pumping. Communities in water scarce areas would still consider Total Iron concentrations of less than 2mg/l as acceptable (MWE 2013) but this particular source at Site 3 is abandoned and people instead collect water from a river that is too risky with reported deaths. A local leader explained that women stopped using the borehole because the water makes them pale with very rough skin to the extent that their husbands do not want to share with them beds. They may try to use lotion but cannot always afford and, to save their marriage, they prefer to risk the lives of their children who collect water from the river. Compared to borehole at Site 4 where the source was improved by replacing GI pipes of the down-hole-pipes with PVC pipes, the improved source recorded a Total Iron concentration of less than 2mg/l and alkalinity of $89.00 \pm 4.0\text{mg/l}$ but is under continuous usage with no complaints. This finding reveals that a water source may have multiple problems that need to be fully investigated and identified differently, to develop appropriate solutions for each case. Fader (2011) recommended that IRP should not be installed in an application that still has its iron pipes and components.

Figure 1. Quality of water sampled from the unimproved IRP boreholes, taken every 30 minutes of continuous pumping

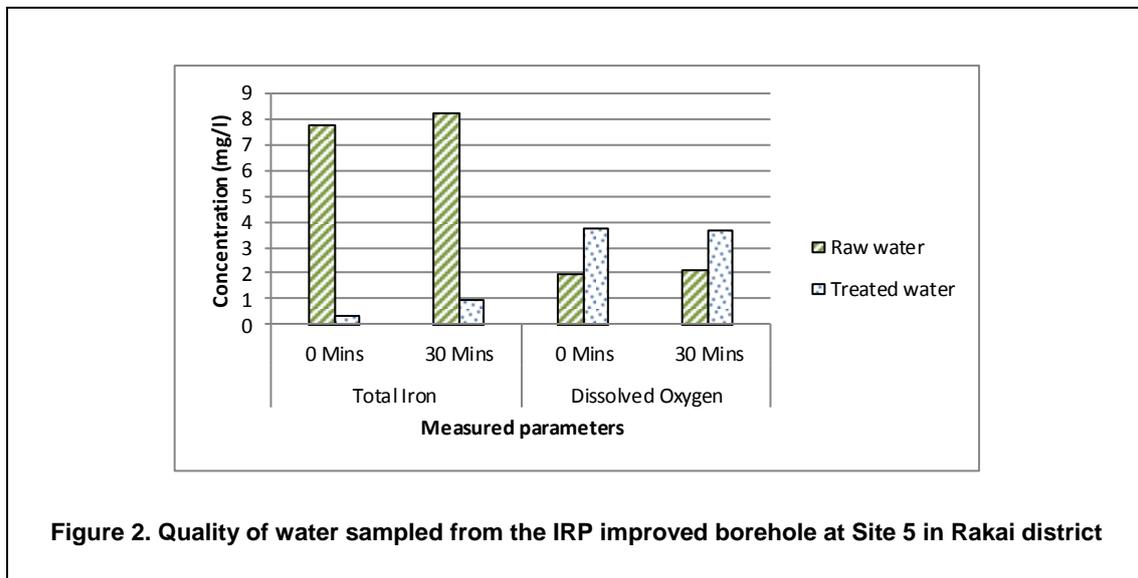
The school management has proved that the IRP can work well with proper operation and maintenance and they have gone ahead to install and oversee another plant for a community at Site 5 in Kibanda Sub County. The school management has also trained the local leaders of the community on how to manage the improved IRP U2 borehole to ensure it serves the purpose. The efficacy of the IRP improved water source that was constructed by the school at Site 5 was assessed. The results show that the plant can reduce the Total Iron concentration and also increase the amount of dissolved oxygen in the treated water (Figure 2).

Figure 2. Quality of water sampled from the IRP improved borehole at Site 5 in Rakai district

Measurements of the selected physicochemical parameters taken over a 30 minutes interval showed relatively small variability with a sharp increase in alkalinity of 105mg/l to 175mg/l in the raw water. Values of the measured parameters in the treated water are with increased dissolved oxygen levels and reduced total iron levels given the nature of the treatment unit operations and processes. A slight increase in Total Iron concentration in the raw water sample after 30 minutes can be explained by the recharging of the aquifer. While the increase in Total Iron of the treated water after 30 minutes could be due to the influence of the volume of water exposed to free air in the aeration unit prior to sampling. This is also noted with the slight decrease in dissolved oxygen after 30 minutes as more oxidation process occurs in the treated water. Further study will optimize the efficacy during continuous pumping process of the IRP and its general performance to enhance the sustainability of the improved water source.
