29th WEDC International Conference

Environmental impact of a drain system failure: A case study

Engr. J.N. Tsuzom and Engr. E.S. Olorunaiye, Nigeria

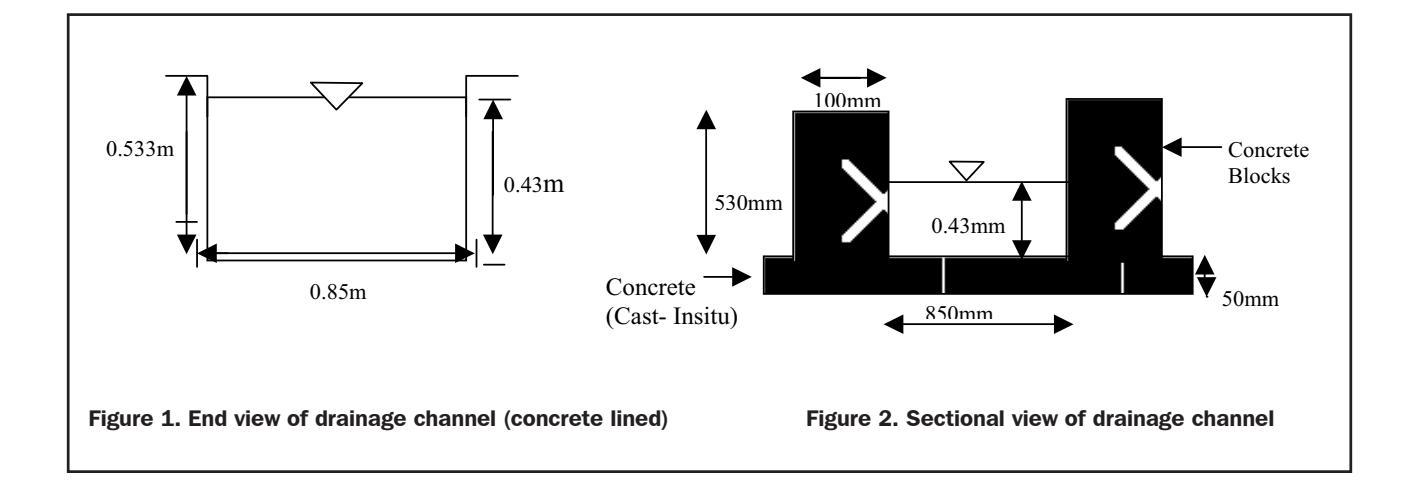
The channel section was cut by digging and excavation, using hand held tools like diggers, shovel and axe. The construction was done to meet the design specifications given in table 1. See figure I.

This was done by blinding the channel bed with concrete (cast-insitu) and laying 225-mm blocks along the channel sides (see Fig. 2). The reconstructed portions of the existing (or main) drainage system were also similarly lined.
