## WATER, ENVIRONMENT AND MANAGEMENT

### Design of hill irrigation in Chirang, Bhutan

Ian K Smout, Robert J van Bentum and Langa Dorji

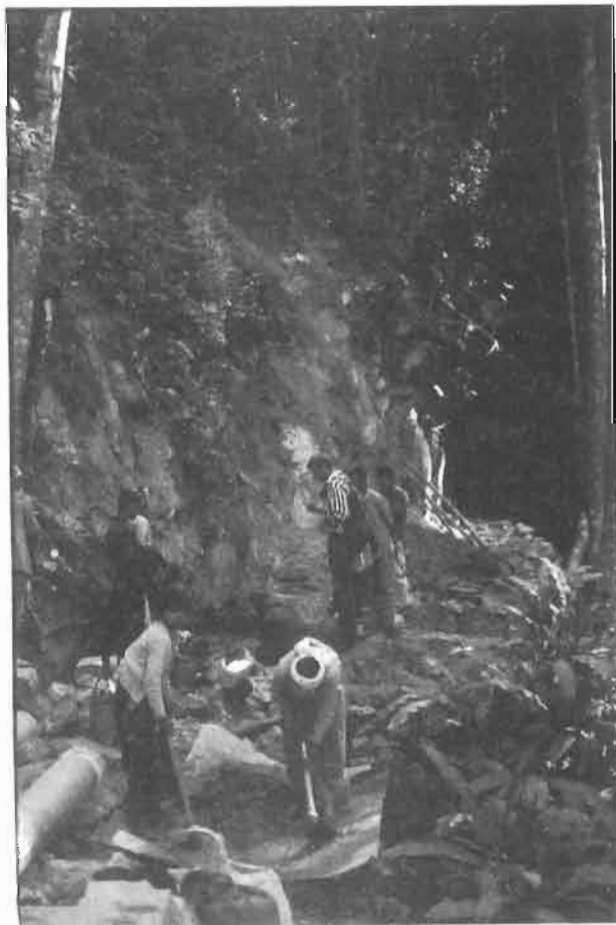
**Photograph 1.**  
Construction of a bench and concrete pipeline

Rock ranging from good to moderately weathered would provide a good stable bench. A rock face could be distinguished by its common pattern of bedding or cracks, though joints might be filled with soil. Before cutting the bench, loose soil, rocks and trees were cleared from above the canal alignment. Drilling and blasting proceeded by cutting a step into the rock at the upstream end, and moving downstream parallel to the rock face to lengthen the bench. All rock loosened by blasting was removed, and the back slope cut back to less than vertical. The bench width was kept to the minimum required for the canal (Photograph 1).

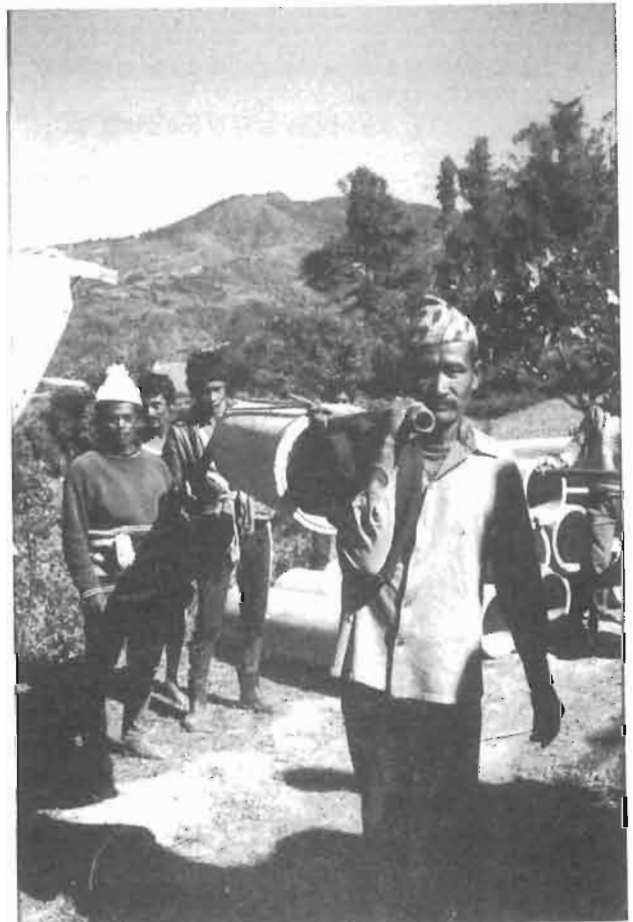
**Photograph 2.**  
Carrying concrete pipe to site

Many lengths of concrete pipeline were installed on the project using pipes up to 300 mm internal diameter in lengths of 1.25m which could be carried to site (Photograph 2). Plain-ended pipes were used, which were obtained from a selected pipe factory, with quality control of materials and manufacture. The pipes were laid at a design slope to overcome the estimated friction and inlet/outlet losses at 1.25 x design discharge. Twin pipes were used if the head was limited, and for the larger canals. At design discharge the maximum velocity through the pipe was less than 1.6 m/s.
