32nd WEDC International Conference, Colombo, Sri Lanka, 2006

**Achieving sustainable sanitation:
Lessons from tsunami reconstruction in Sri Lanka**

M.A.I.B. Navaratne, Sri Lanka

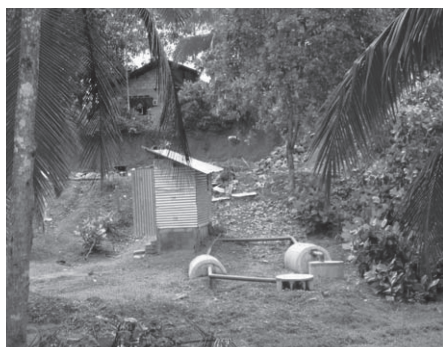
Most often the wastewater management technology used by reconstruction agencies is the concrete hume-pipe septic tank and soakage pit system shown in Photograph 1. However, this system has failed to perform as a sustainable sanitation system in the permanent housing schemes. Cylindrical hume-pipe septic tanks do not conform to the SLS 745: 2003, the Sri Lanka Standard for the design of septic tanks and effluent disposal systems. Design and sizing of these systems are flawed and result in flushing of solids into the soakage pit and short circuiting. This is due to low settling depth, settling area and volume. The failure is not in the septic tank technology but the product used. Though these units were used as quick stop gap solutions for transitional houses in the short term, more appropriate technology needs to be used in the permanent housing schemes.

Photograph 1. A Hume-pipe septic tank system used in a transitional camp in Kalutara

- Discontinue the use of concrete hume-pipe septic tanks in tsunami housing schemes where environmental conditions are not conducive for their use.
- Promote the use of designed septic tanks, anaerobic filters, wetland and percolation bed units suitable for the given site conditions. Corea (2001) and SLS 745: 2003 explain the design of such units for on-site treatment of domestic waste. Such systems have been successfully used by some agencies for tsunami housing.
- Use of settled sewage with shallow sewers coupled with off-site treatment is an alternative for high-density housing schemes. Mara (1996) explains the design of such systems.
- The technology used should not be based on minimum cost and, quick and easy installation. It should focus on the functional performance of the system.

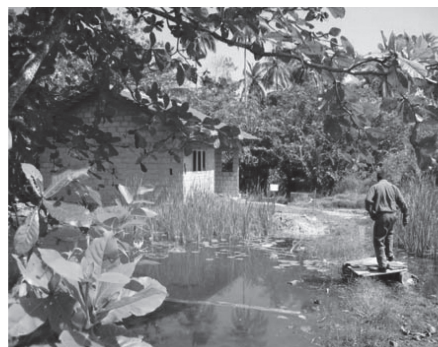
Many lands identified for tsunami rebuilding were unsuitable due to high water table and marshy conditions as shown in Photograph. 2. This resulted in back-flow in toilets, and low or no soakage of wastewater resulting in the failure of sanitation systems as depicted in Photograph. 3. According to a study by Fraser Thomas (2006) for National Water Supply & Drainage Board (NWS&DB), which looked at tsunami housing schemes with more than 250 housing units at a site, more than 75% of the sites identified encounter problems with high ground water table. Further, almost a similar number have problems relating to soakage and flooding. The study data is given in Table. 1.

Photograph 2. Water logged marshy land identified for tsunami housing in Kalutara

- Water supply and sanitation needs must be given high priority in identification of land for housing construc-

tion. Suitable land identification, in turn would minimize negative impacts of water supply and sanitation in many of these sites.

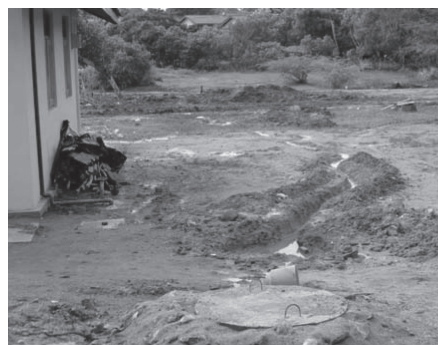
Photograph 3. Failed hume-pipe septic tank and soakage pit system due to lack of soakage resulting in unhygienic conditions in a Kirinda housing scheme

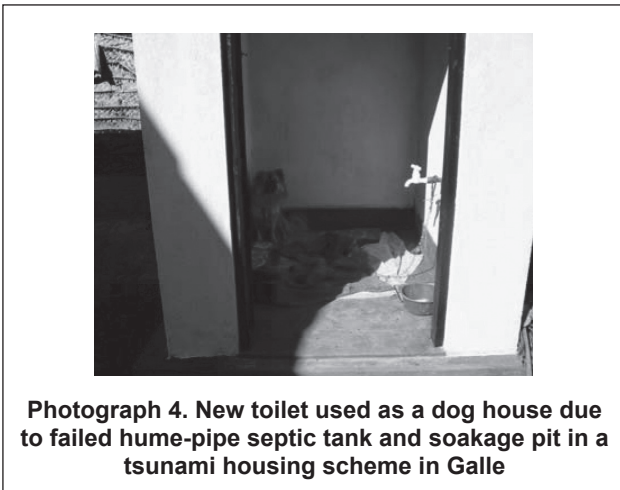
The lack of such a body results in substandard projects being delivered to recipients who cannot demand better conditions as houses are given as grants. However, in some cases recipients have refused to move into new housing and preferred to live in the transitional shelters in protest of the substandard sanitation provided. Failure of such systems after hand-over is not considered to be a serious problem as at present there is no monitoring agency to look into the long term sustainability of housing schemes. Such system failures result in sanitation facilities being used for other purposes as evinced in Photograph. 4.

Photograph 4. New toilet used as a dog house due to failed hume-pipe septic tank and soakage pit in a tsunami housing scheme in Galle
