41st WEDC International Conference, Egerton University, Nakuru, Kenya, 2018

**Assessment of the functionality of rope pumps for
sustainable water supply in rural areas of Malawi**

PAPER 3041

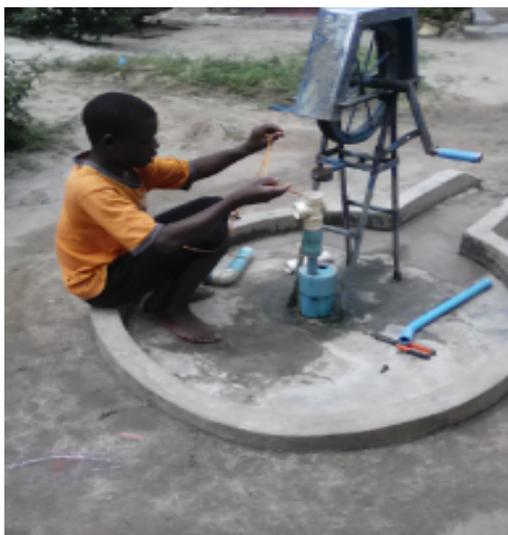
Photograph 2. Maintenance of Rope pump

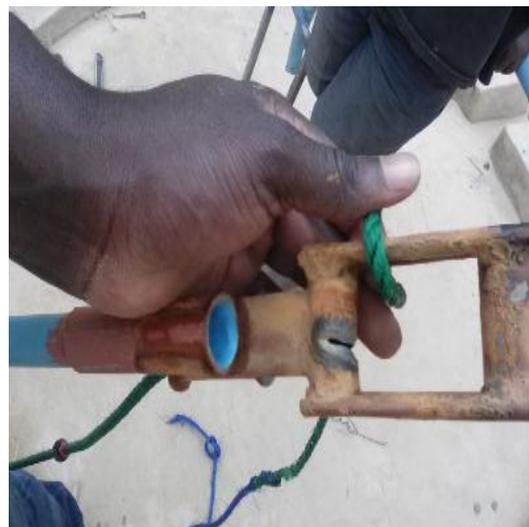
Photograph 2. Worn out guide box

Observation were also made on some cases of poor installation of the Rope pumps, compromised civil works and the use of low quality materials which compromised the functionality of the pumps. Lower class (thinner) PVC pipes easily break creating a possibility for the entry of the objects into the well which also possibly affect the quality of water as well as creating sharp edges which affect the durability of the rope.
