41st WEDC International Conference, Egerton University, Nakuru, Kenya, 2018

Water retention landscape: mini catchment approach

G. N. Wambugu (Kenya)

PAPER 2997

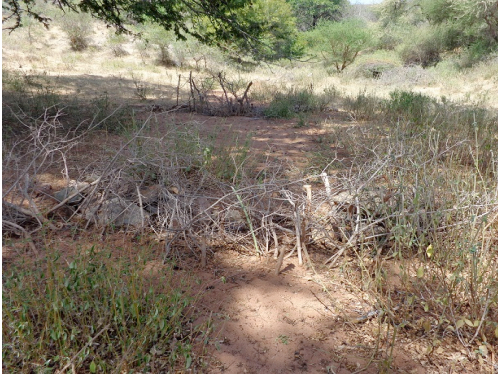
Photograph 1.
Series of Stone Check dams

The major work on the catchment included tree planting, construction of 6 major masonry check dams on the main seasonal Musosya stream and construction of 1100 stone check dams on small gullies. Masonry check dams were constructed with rubble stones and mortar while stone check dams were made of simple pile of rocks arranged across small gullies and buttressed on downstream side with planted vegetative tree branches. Gabions were used for medium sized gullies. All the 6 rubble masonry check dams were installed with a 4 inch (10cm) vertical drain pipe to enable farmers to observe water levels and how long it lasted after the rains, this being an indicator of the success of protection work that had been carried out. Work was done on the local road and path/animal track network by making diversion trenches to nearby farms. These networks are usually a big source of soil erosion since a significant amount of storm water run through them. The road water runoff that was directed to private farms was made to spread on relatively flat land or was directed to a series of pits (Zai Pits) that were later planted with bananas, pawpaw's, or other crops. Zai is a term used in Burkina Faso and refers to planting pits 20-30 cm filled with organic material/dry plant biomass for planting seeds/seedlings (Motis et al 2013). Apart from the project requirement for contour trenches in private farms for terraces, strategic locations were identified where communal terrace work was done amounting to a total 46km communally made terraces. The conservation work at public locations and some major trench work on private farms was carried out communally by the community members who received a cash for work stipend. Tree seedlings were planted on some strategic areas near to the reservoir. They were planted on communal areas and on some private farms adjacent to the reservoir. To ensure the trees survived, cluster leaders and community members planned for a guarding rota especially when the trees were very young. They also made a rota for watering the trees after the rains subsided. For additional security, each tree seedling was protected with a circular stick mesh about 80 cm high. This prevented any goat or other animal that may have escaped the eyes of the guard from harming the young trees.

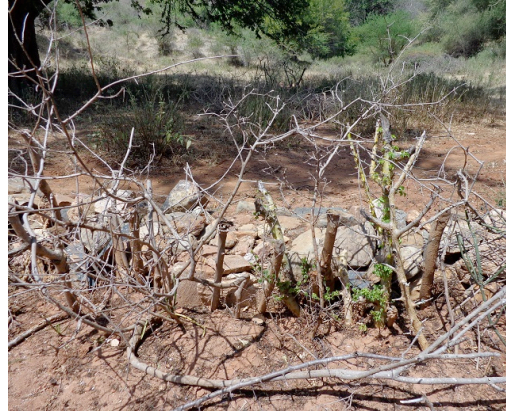
Photograph 2. Check dam:
note sprouting vegetative buttresses

As a result of the massive conservation work, most of the small gullies were healed (filled up with silt) and the vegetative tree branch buttresses sprouted making the stone check dams permanent. There was also substantial 'healing' in the major gullies and the seasonal stream though much less than the small gullies. Two lined hand dug wells constructed on the downstream of reservoir provided adequate water to serve the community throughout the year. One of the wells provided a yield of more than 2m³/hr and was equipped with solar water pumping system and community uses the water at their demonstration farm as well as for drinking purpose. Water recharge in the wells has improved greatly due to increased water retention in the catchment and currently there is adequate and sustained water flow into the wells being experienced. The project reached 1440 beneficiaries and the per capita cost was \$143 per person and good water conservation results are visible. This could not have been achieved if the project funding was pegged on a low per capita funding.

- Simple soil and water conservation technologies like stone check dams buttressed with vegetative tree branches makes a permanent check dam to check soil erosion. This is appropriate for gully head treatment and will heal a small gully before it gets worse.

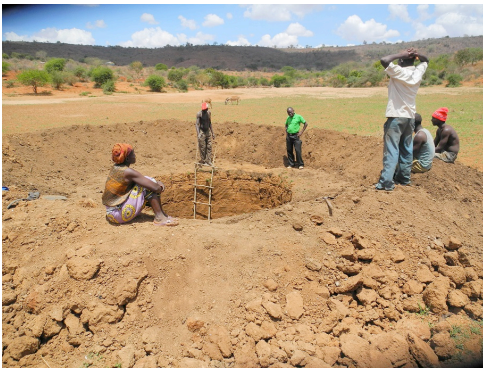
Photograph 3. TEST WELL at reservoir
before desilting:
note reservoir in background

- The rehabilitation of the dam had been planned as the last activity in the project. This however became a challenge since a lot of water was retained due to the conservation efforts (subsurface flow) and it was a challenge to de-silt the reservoir. This order should be reversed de-silting coming first and conservation work to follow (if new dam, it should be constructed first). A 3 m deep well had been dug on the reservoir in the first year of the project in September and no water was encountered, however, water was encountered above 3 m while de-silting the reservoir in the second year in the same month though the annual rainfall was similar in both years.

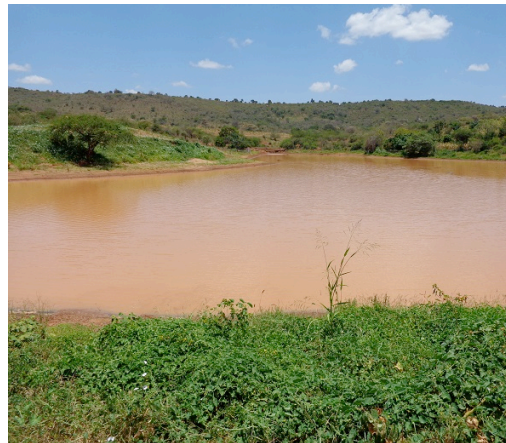
Photograph 4. Reservoir after desilting

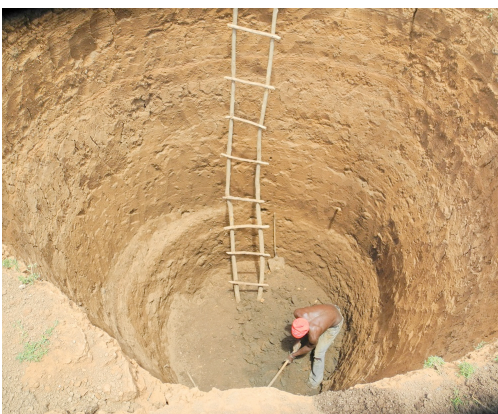
Photograph 5. No water at 3M deep
WELL prior to desilting

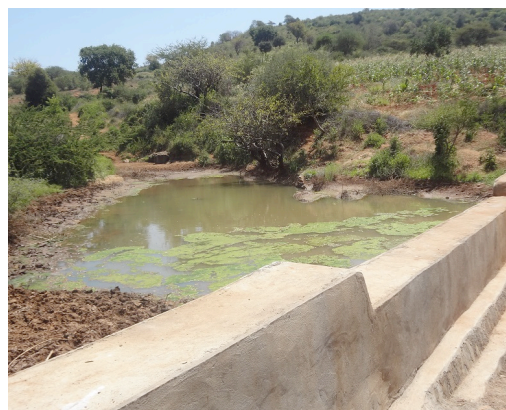
Photograph 6. Water trapped behind
masonry check dam allowing
slow seepage
