**Blue Drop Audits
Support from DWI to DWA**

Dr S. D. Lambert

April 2010

Blue Drop Audits – Support from DWI to DWA

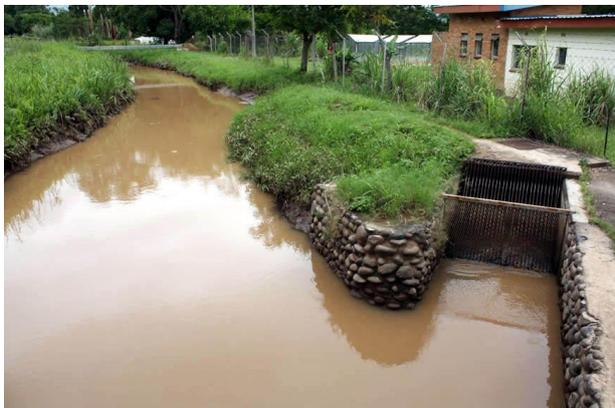
The source water for the works was a small river, running close to the works perimeter. Due to massive storms and nearby highway construction activities, this source was heavily turbid (>400 NTU) at the time of the audit, leading to a number of treatment problems. However, a works should be able to treat all qualities of raw water entering it, and reliance on a single raw water source, as well as any issues that might arise with it, should be risks highlighted (and mitigated against) in the DWSP.

Raw water source and works intake

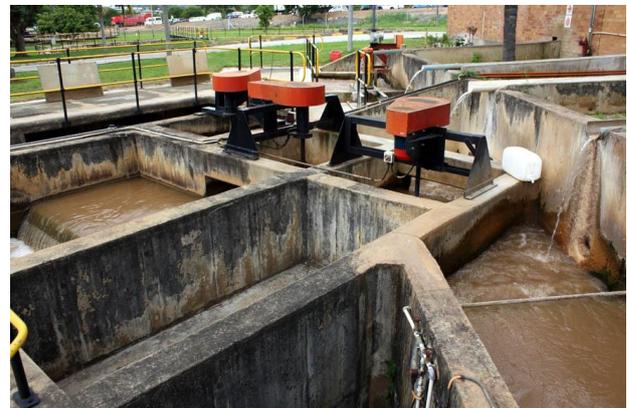
Coagulant dosing and mixing

Coagulation of the raw water was achieved by the addition of aluminium, lime and a polyelectrolyte. However, no jar tests to optimise the dosing were undertaken by the operators on-site. Instead, the coagulant suppliers had to be called each time meaning that the works was unable to react to rapid changes in raw water quality, such as at the time of the audit. It is recommended to the Municipality that works staff are appropriately trained in such fundamental techniques. Actual control of the coagulant and lime dosing also appeared to be relatively poor and should be improved.

Coagulant mixing was achieved with dilute solutions poured from a height into a series of mechanical mixing chambers. Sacks of lime were stored under cover, although in poorly maintained piles, with a high potential for contamination. It is recommended that these storage conditions be improved.

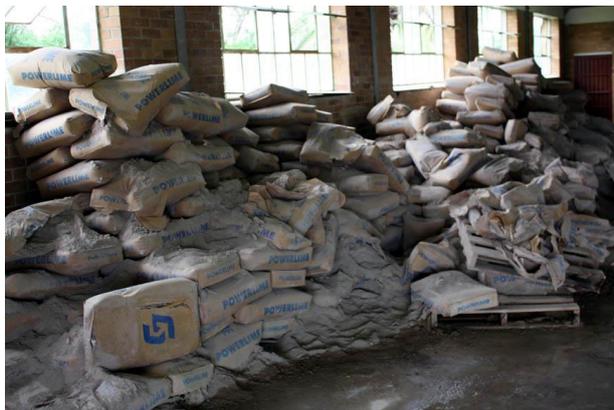
Lime storage

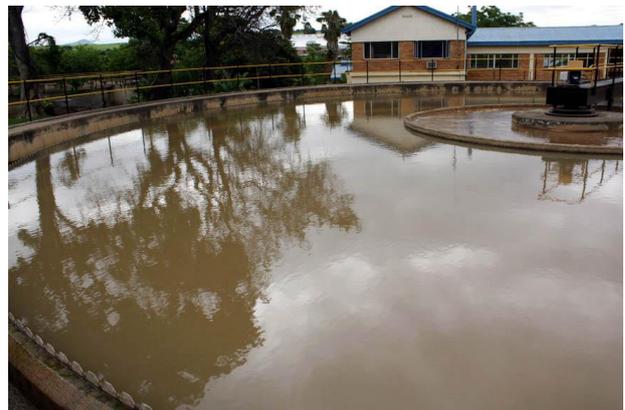
The high turbidity in the raw water source appeared to be caused largely by silt and clay particles and thus should be relatively easily removed through water treatment. However, possibly due an inadequate coagulant dose or reaction pH, very little floc formation was observed upon coagulant addition or, in fact until filtration where pin prick microflocs were just discernable. The implications are that treatment of the water was poor, the clarification process essentially by-passed, and the potential for poor final water (microbiological) qualities high. The turbidity of the final water was greater than 1 NTU.

Turbid water carry over in the clarifiers

As the rapid sand filters were effecting a large part of the solids removals achieved, they being backwashed on a continual cycle, and three times more often than normal. However, backwashing was manually controlled and without any apparent defined operating protocol. Hence, while air scouring was undertaken for a period of time, it was unclear what the target duration was, and there appeared to be no rest time allowed between air scouring and water washing. As a result, air could still be seen bubbling through the media during water washing, increasing the potential for media carry over. The air scour distribution pattern was very even, meaning that the under-bed nozzles were in good condition. The water wash was undertaken for a period of time, although its precise duration again did not appear to be closely defined, and the filter not washed until the wash water ran clear. It is therefore strongly recommended that all operational activities on the works are proceduralised and used by the workforce (taking into account levels of literacy).

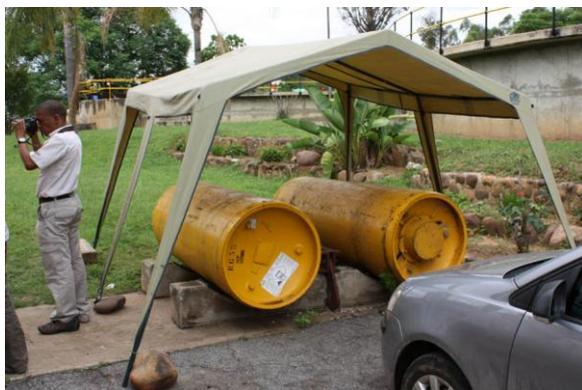
Disinfection is the most important water treatment process and achieved at the Nelspruit works by gaseous chlorine in 100kg drums. Storage of these drums at the time of the audit posed a major hazard, with two drums laid outside, shaded from the sun by a temporary gazebo, and pointing in the direction of a major highway barely 40 metres away. The potential risks associated with the release of chlorine from just one of these drums is unimaginable and requires an immediate resolution.

Storage of Chlorine drums

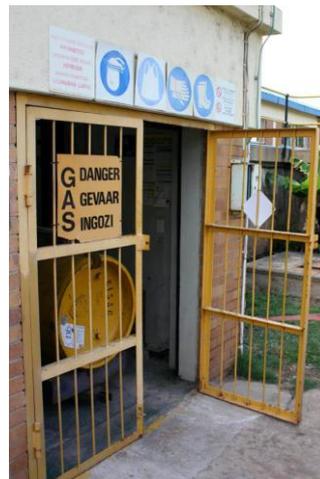
Chlorine dosing room

The chlorine dosing room was also not up to current operational requirements. Fitted with an iron bar gate, it should instead be sealed to ensure that all chlorine leaks are fully contained and exposure risks minimised. Gas sensors, alarms and forced ventilation systems should thereafter control entry. Although fitted with a gravimetric system for determining chlorine use and drum contents, this appeared to be in a state of disrepair and not used. In addition, no obvious record of drum changeover dates was maintained. Coupled with the lack of any duty-standby or auto-changeover arrangements it was unclear how continuous chlorine dosing of the final water could ever be achieved and, therefore, whether and how much water is supplied undisinfected.

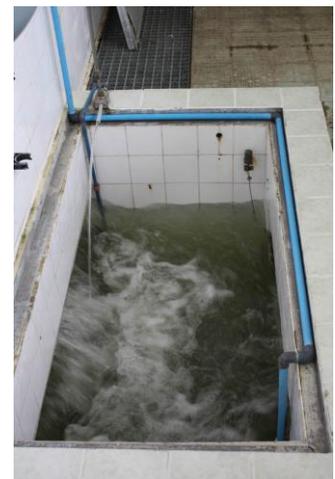
Chlorine dosing

Chlorine contact times at normal flows were stated as being about 30 minutes, with residual chlorine concentrations well above 1 mg/l. However, it was still unclear how effective the disinfection actually was. Chlorine was dosed as a high concentration solution stream into the treated water with, it would appear, mixing achieved hydraulically. The condition and baffling of the contact tank were unknown, as well as how the effective chlorine contact times had been determined. The contact time at full works flow was stated to be only about 20 minutes, below the minimum 30 minutes recommended by the World Health Organisation. Similarly, the final water pH (close to pH 9) and turbidity (above 1 NTU) were both above the maxima recommended by the World Health Organisation, implying very little disinfection potential (low hypochlorous acid content), and the potential of a very real microbiological risk in the drinking water supply.

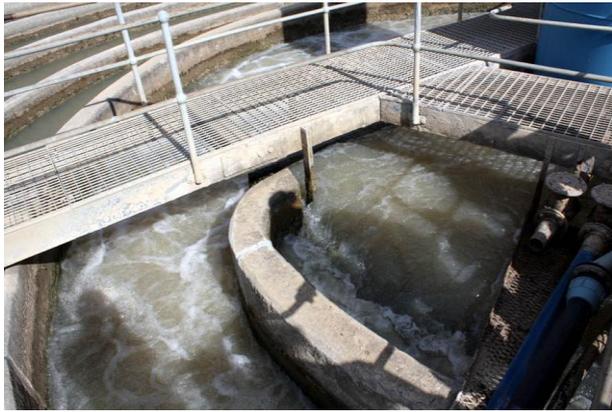
Flocculation is achieved in a series of spiral flocculators, with ever decreasing velocity gradients as the water travels from the centre outwards. The works can operate with only one flocculator out at a time, each being taken out once a year for maintenance. With no moving parts, the main maintenance issue is the accumulation of lime in the static mixers.

Inlet to Spiral Flocculator

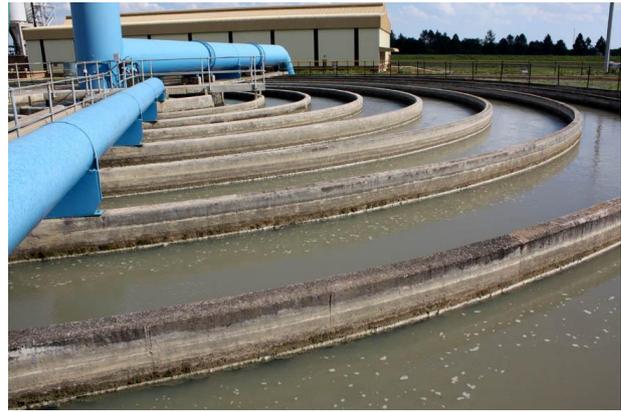
Spiral Flocculator

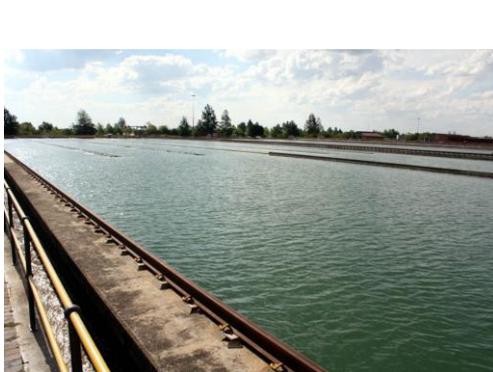
After flocculation, Rand Water uses a number of very large flat bottomed clarifiers, with retention times of 4 hours, to produce water with a turbidity of 5 NTU at the outlet weirs. Depending on the turbidity of the incoming raw water (60 – 120 NTU), between 95% and 97% of the suspended particles are removed during clarification, producing between 500 to 1,300 t/d of dry sludge. This is continually pumped from the bottom of the clarifiers as a thin slurry, containing 3% w/v dry sludge, which is thickened and then dried by evaporation. Sludge supernatants are returned to the head of the works (into the canal).

Flat bottomed clarifier

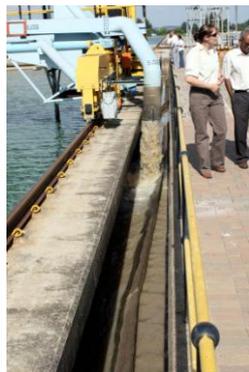
Desludging

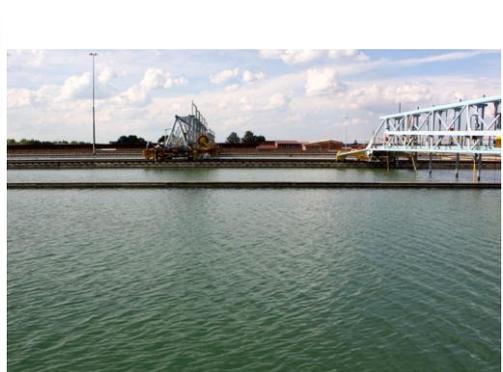
Desludging gantries

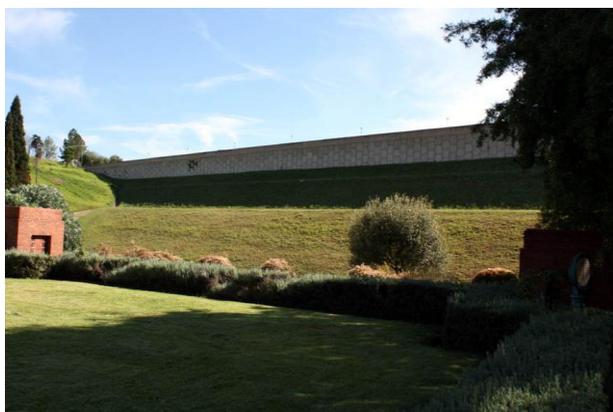
Water is abstracted from the Rietvlei Dam by means of an intake tower. The water is characterised by very low turbidity but high algal activity, including blue-green algae, which is prone to cause taste and odour problems in the final drinking waters. Three different abstraction points at varying levels in the tower can thus be used, depending on the water quality at each level. Floating solar bees, which pump water from depth and over the reservoir surface, are also in use for algae control, and claimed to have been very successful.

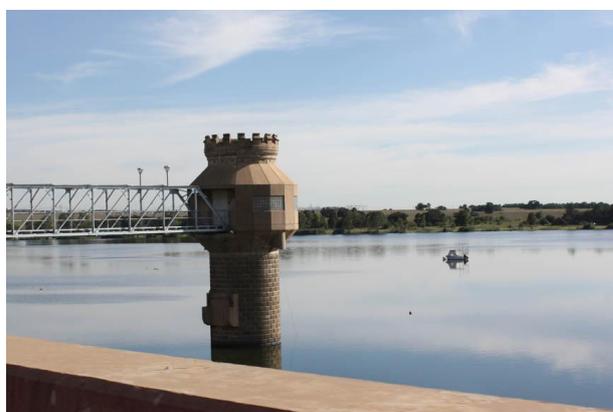
Raw water intake tower (and a solar bee)

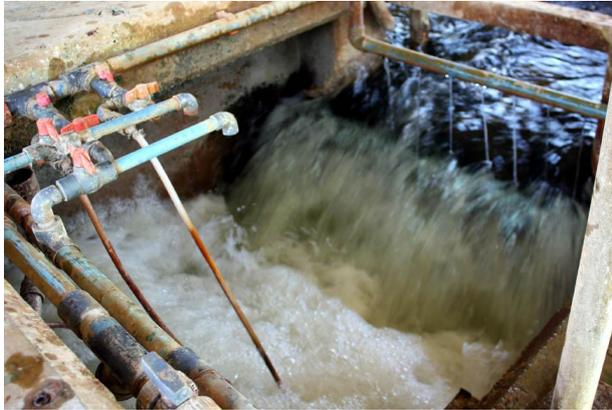
Aluminium sulphate is used as the primary coagulant, although ferric chloride is held in reserve as an alternative. Polymer and lime are also added at the same time as alum to aid floc formation and for pH correction, respectively. Doses are flow proportional and adjusted weekly as a result of jar tests, although daily meetings are held where treatment performance issues are discussed. The chemicals are flash mixed and the water then flocculated through a series of sinuous baffled channels.

Coagulant dosing

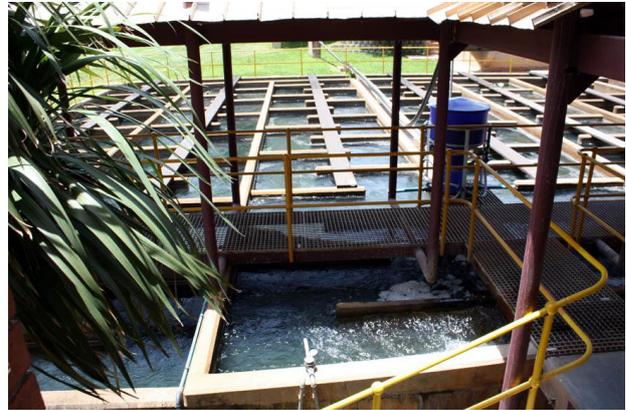
Flocculation (and CaCl₂ dosing – blue container)

There is provision to dose calcium chloride to aid flocculation at the beginning of the baffled channels. However, how specifically this was controlled and the possible risks from overdosing should be further explored.

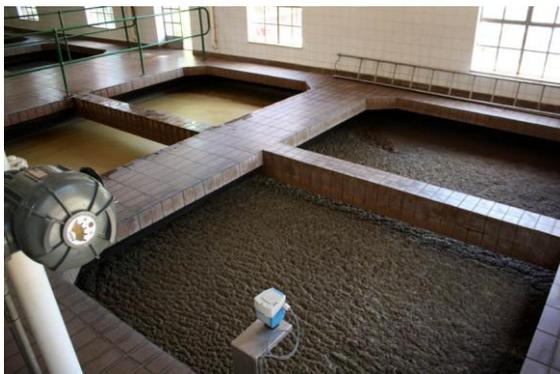
The hydraulic retention of the flocculation channels is approximately 10 minutes, after which the water enters one of 10 Dissolved Air Flotation-Filtration (DAFF) units. The flotation process removes about 70% of the flocculated particles as a scummy brown layer on the water surface. This was observed to be relatively bulky and thick in some units, which could potentially lead to an increase in clarified turbidities. The reasons for the desludging frequencies employed might be an issue to be explored further.

DAFF units

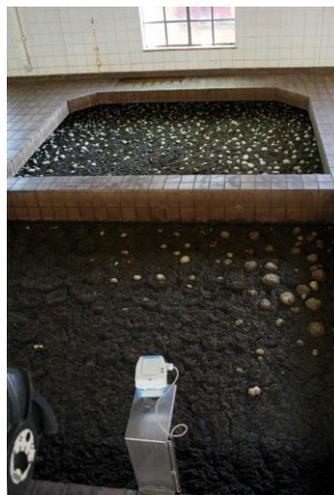
Bulky sludge blanket

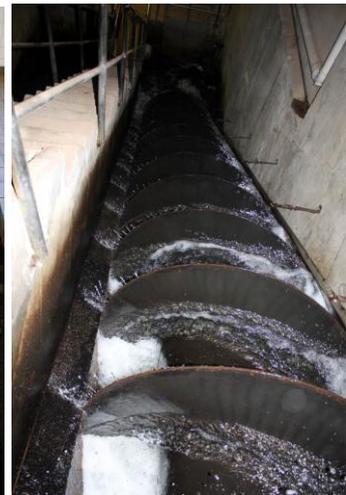
Archimedes screw

After clarification and filtration, two 10 m Archimedean screw pumps lift the water 4.5 m to enable it to gravitate through the remainder of the works. Ozone is to be installed to aid in the removal of taste and odour and the precipitation of iron and manganese. Currently however, the remainder of the treatment consists of 20 Granular Activated Carbon (GAC) beds, installed in 2000 for the removal of colour, tastes and odours, followed by disinfection. Disinfection is accomplished by chlorination (chlorine gas).

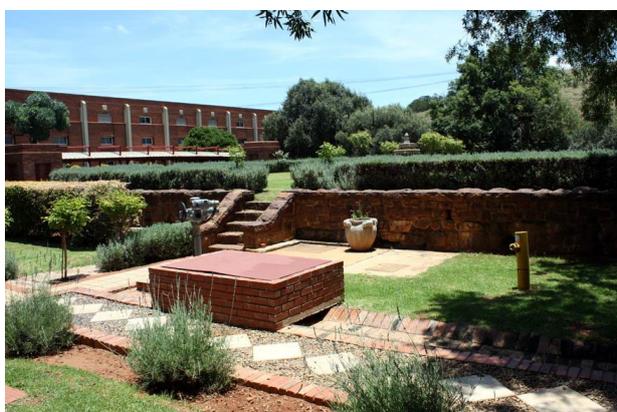
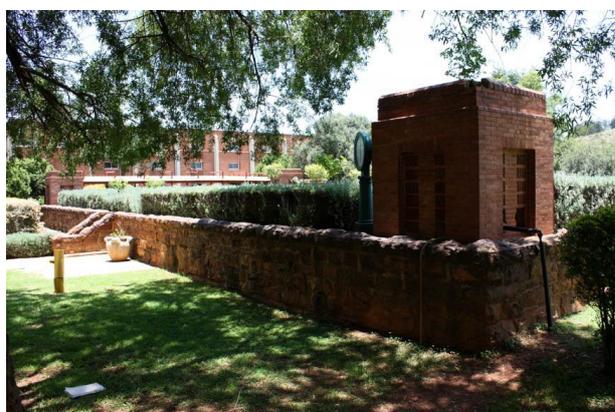
Following disinfection, the treated water flows into an on-site storage reservoir where water from boreholes and fountains in the nature reserve is added. From the reservoir, the water is pumped to two of the largest storage reservoirs in Pretoria. At the storage reservoirs the water is blended with water provided by Rand Water and water from other boreholes and fountains.

On-site storage reservoir

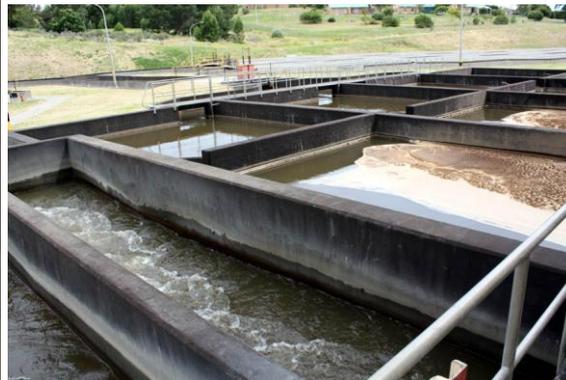
Flocculation and clarification

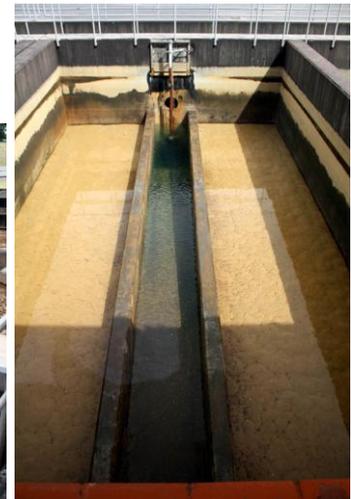
RGF (partially drained)

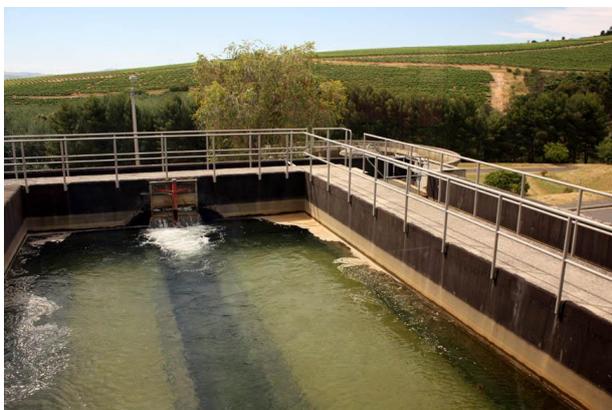
RGF, returning to service after back-washing

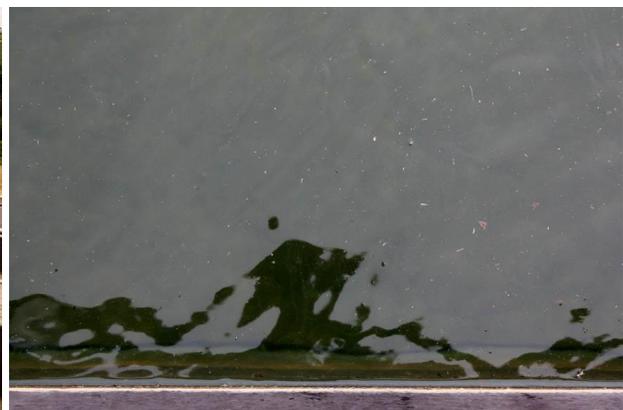
Crack in sand bed along a RGF wall
