Sustainability of hand-dug wells in Tanzania: results from a post-evaluation

L. Gill, & F. Flachenberg (Ireland)

BRIEFING PAPER 2088

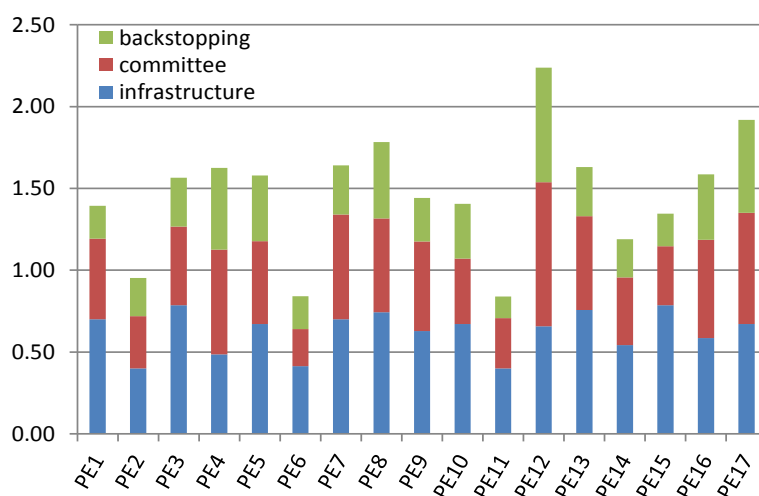
The results from the three different sustainability indices (infrastructure, committee and backstopping) have been normalised (i.e. expressed on a scale of 0 to 1.0) for each WP and then added together for an overall comparison, as showed in Figure 1. These final cumulative sustainability scores do match the same general feeling as to comparative sustainability's between WPs from the site visits and WP point committee interviews: i.e. PE12, PE17 and PE8 were the best whilst PE2, PE6 and PE11 were clearly failing. The scores have then been used to correlate overall sustainability of WPs (out of 3.0) with respect to their age (Figure 2) which interestingly shows no significant difference. Another finding, however, is that the sustainability of the water points seems to increase with the higher number of users per well (Figure 3) which is perhaps an indication that the more highly used WPs are more valued by the community.

Figure 1. Cumulative sustainability indices (out of max. 3.0) for the 17 water points
