20th WEDC Conference

AFFORDABLE WATER SUPPLY AND SANITATION

Wastewater disposal and problem soils in Lanzhou, China

Tom Dijkstra, WEDC, UK.

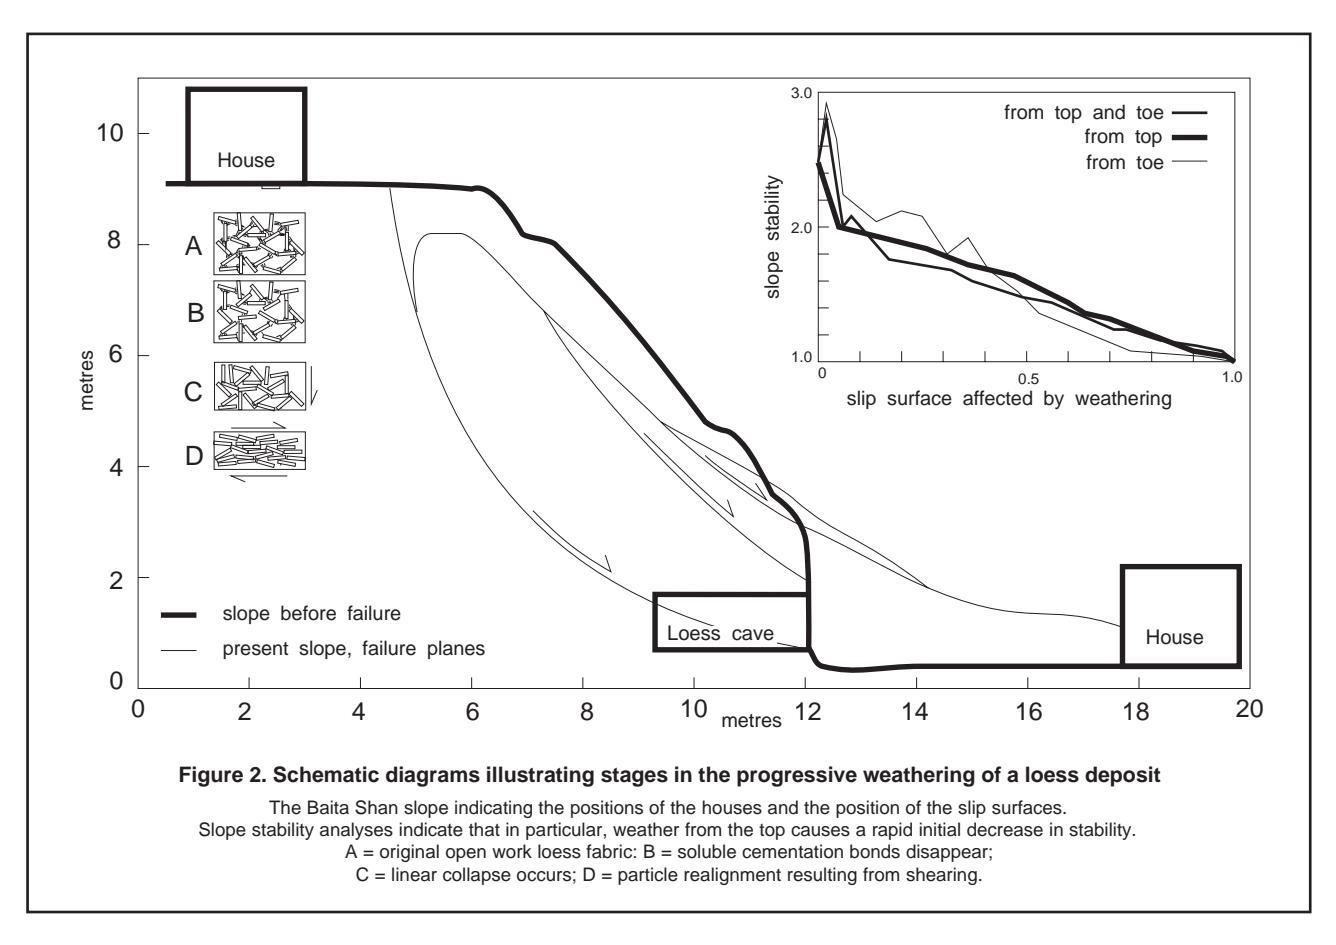
The results of the analyses are shown in Figure 2. With the weathering from the top of the slope a strong initial decrease of slope stability occurs, which is explained by the considerable drop in effective cohesion values when the loess changes from an undisturbed into a weathered ('remoulded') state and the relatively small effective normal stress acting on the failure plane at this point. This effect gradually becomes less important with the increase in the effective internal friction angle taking effect at greater depths after further progression of the internal weathering of the slope. Slope stability analyses carried out while adding weathered slices from the toe of the slope indicate an initial increase in factor of safety due to the higher internal friction angles of the weathered slices causing the lowest slices to act as buttresses against movement of the upper parts of the slopes. After adding the third slice this effect is diminished by the changes in the effective apparent cohesion values, leading to a sudden drop in the safety factor. This curve does not follow the relatively smooth progression of weathering from the top, but for certain additional slices the factor of safety increases above the previous value. The reasons for this are thought to be a combination of the complexity of strength parameter variation (c' falls, rises and then falls again while tan phi' rises then falls), the irregular pre-failure surface profile and the considerable influence of effective normal stress up to at least 50% weathering, and the rapid inclination of the failure plane.

During the simulation of the combined effects of weathering of the top and the toe of the slope an initial increase in factor of safety is observed, which is immediately followed by a rapid decrease and a subsequent small increase. Both increases are caused by the higher values of the effective internal friction angle of the remoulded loess. These higher values are particularly effective in the lower part of the slide, where the effective internal friction angles are significantly higher than the local slip surface angle measured at the base of each slice and the effective normal stress is greatest. The effect will be even more pronounced for larger mass movements where the changes in effective internal friction become relatively more important than the changes in effective

cohesion. Figure 2 indicates that slopes which, in an unweathered state, have safety factors close to unity might fail after only a short period of progressive weathering. This process will take considerably longer for the initially more stable slopes. Within the urban environment the man-made cut slopes are frequently close to equilibrium and therefore moderate amounts of weathering affected by *e.g.* the uncontrolled disposal of waste water may bear great risks for these sites.
