28th WEDC Conference

Inner murchison bay – water quality trends

Ms Sarah M Tibatemwa, Uganda

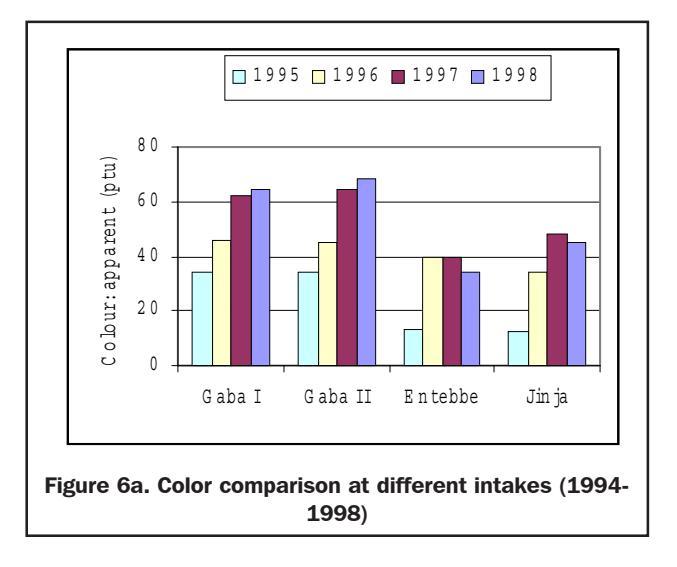
Data analysed showed that there was a significant increase in colour (apparent) of raw water for the period under consideration (Fig.1 below). There was an indication that colour of treated water increased with increase of colour of raw water (Fig. 11 below). Water treatment has apparently become more complicated due to the presence of organic matter as result of eutrophication. Presence of blue-green algae has been identified, and this could be the cause of high colour in both raw and treated water (Kanyesigye, 2001).

- There was considerable increase in the colour of raw water (two to three times) from the IMB for the period under consideration.
- Increase in colour was not due to metallic ions such as iron and manganese
- Colour may be due to organic matter from decaying vegetation and/or industrial waste
- Bacteriological quality at the level of £ 100 FC/100ml was acceptable for a surface water source. This is based on faecal coliform content only
