Chapter A-1

Primary collection equipment

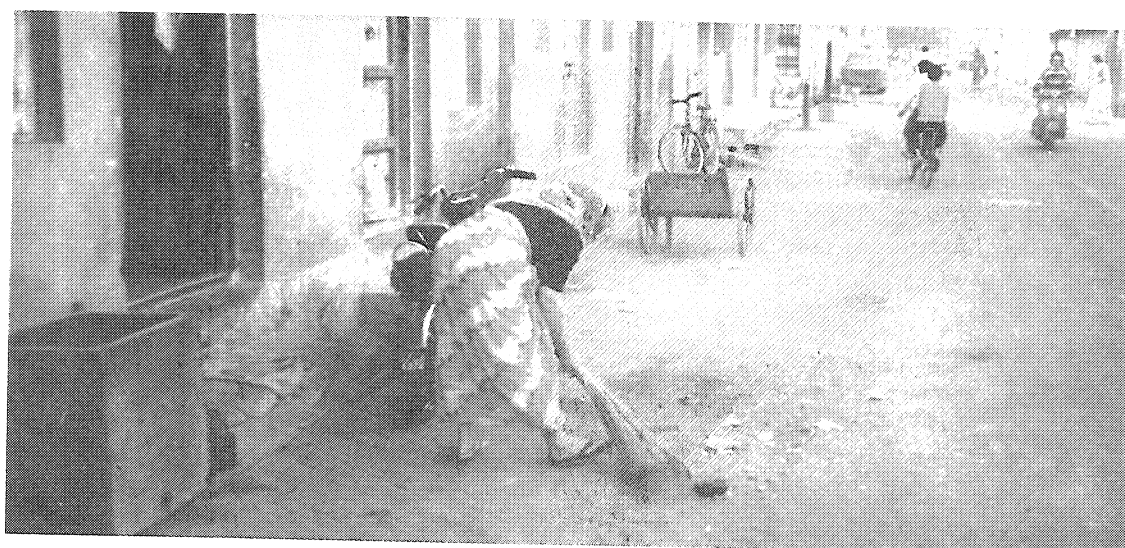
The simple, short bunch broom was in widespread use in many Indian cities, but not Mumbai. Because the user must bend down to use it, back pain may result from prolonged use. The sweeper is also closer to the dust that is being stirred up and so may be more at risk from Tuberculosis and other respiratory infections than a sweeper who has an erect posture. It also appears degrading - and perhaps dangerous - to be stooping or crouching in a crowded street. See figure A-1.3

Figure A-1.3 Sweeper using simple bunch broom - note her stooped position

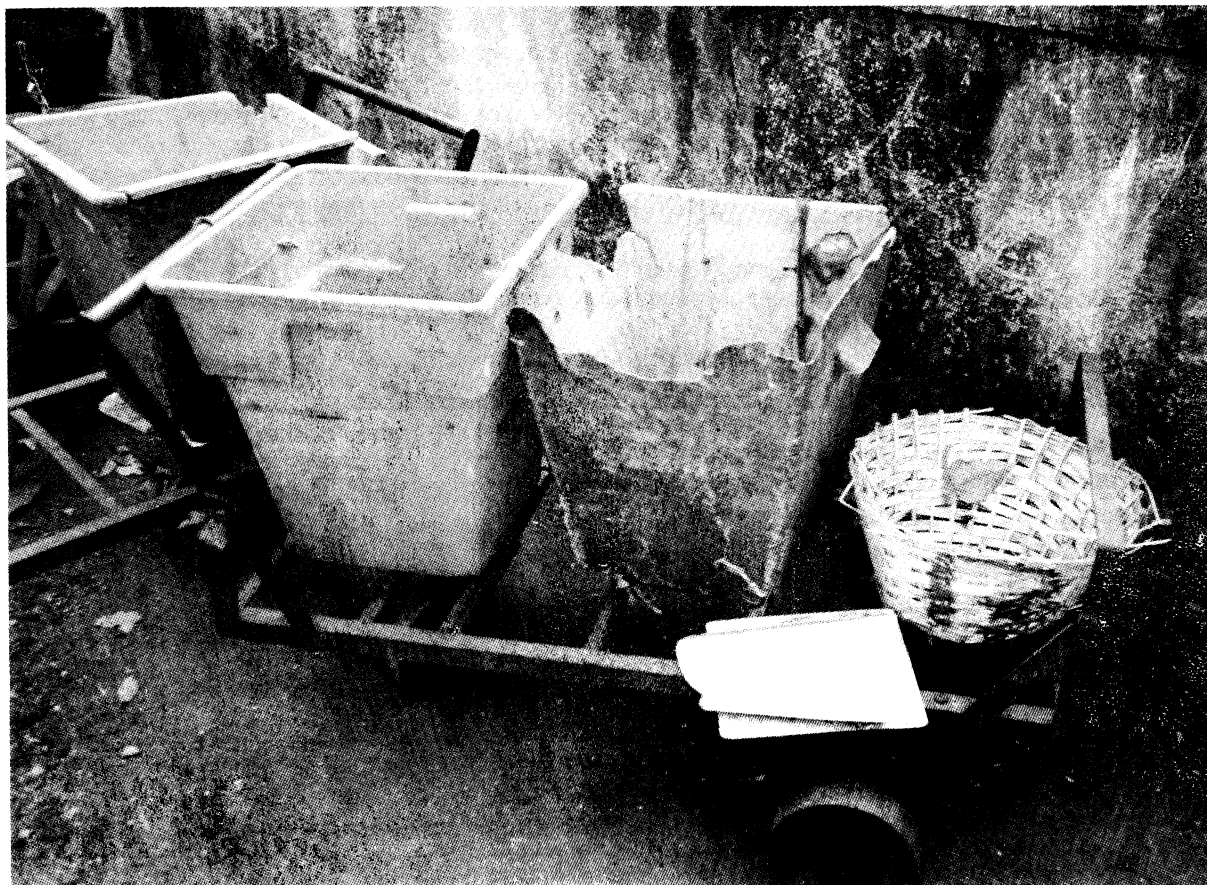
Figure A-1.4 Containers used by sweepers (On the right is a bamboo basket; next to it is a damaged FRP bin, and next to that is a new design of plastic bin.)

More recently moulded plastic bins have replaced the FRP type. They are made from LLDPE (Linear low-density polyethylene), were lasting up to two months longer than the FRP bins, and cost a little less (Rs 542 each). The problem of losing the bins to recycling was tackled by requiring that sweepers who wished to have a new bin should "trade in" the old bin.

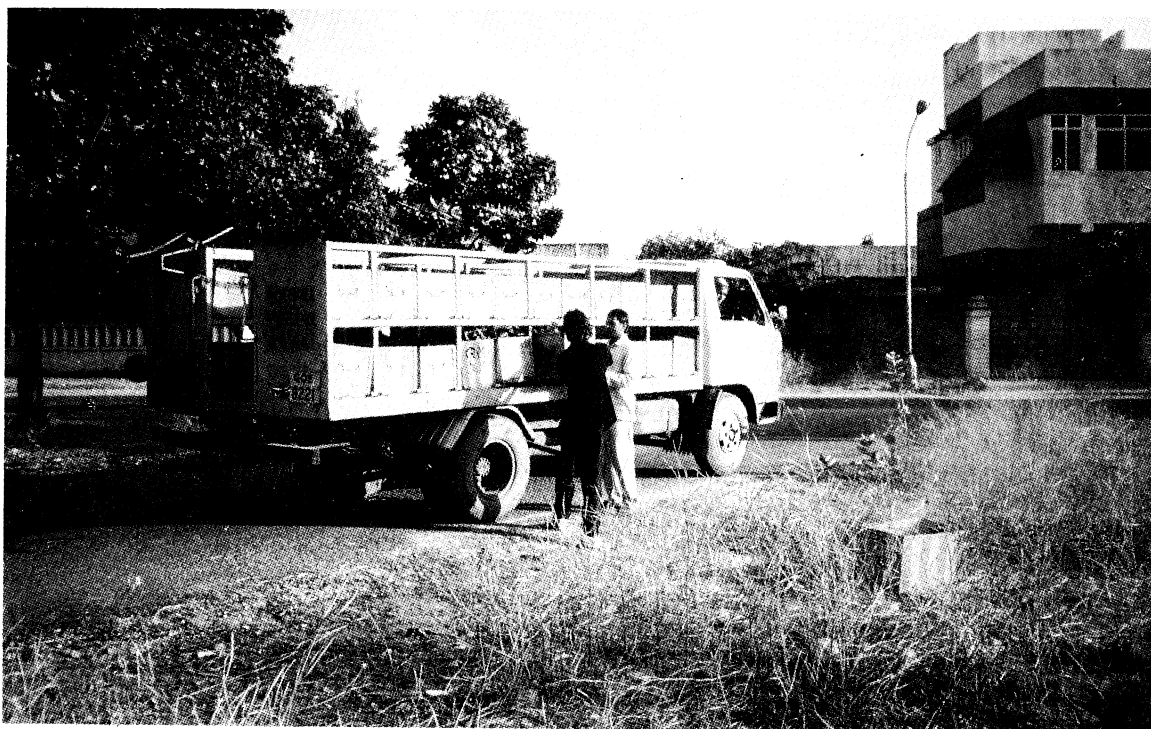
The basic equipment is shown in figure A-1.6. The photograph shows the purpose-built truck which can carry 44 rectangular community bins like that shown in the right foreground. A sample bin was measured and found to be 335 mm deep, 630 mm long and 350 mm wide, giving a capacity of about 75 litres. (The capacity of the bins was normally quoted as being 80 litres, so perhaps the sample bin that was measured was smaller than most of the others.) The system concept was that the bins were distributed on the basis of one container to every 25 families, they were exchanged every day for an empty bin, and the loaded bins were carried on the special truck to a large hook-lift container, into which the contents were tipped. The benefit of exchanging containers rather than emptying them was that no dust or litter were spread in the residential area, as they might be if the waste were transferred at the container location.

Figure A-1.6 The Ahmedabad exchangeable community bin system

The scheme was started in 1988-9, when 2500 bins and 12 trucks were purchased. The trucks were to make two trips in an 8 hour shift, and the crew of each truck was one driver and two labourers. Each container was to be exchanged daily. The containers were painted in the distinctive colours of the Corporation - yellow and saffron stripes.
