## The importance of looking back study in WATSAN projects

*Yubraj Shrestha, Nepal*

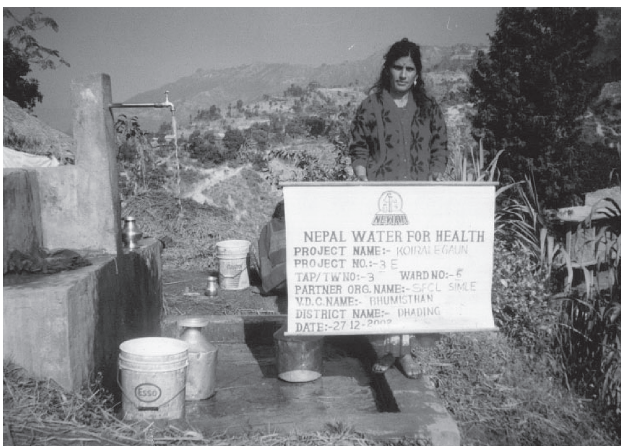
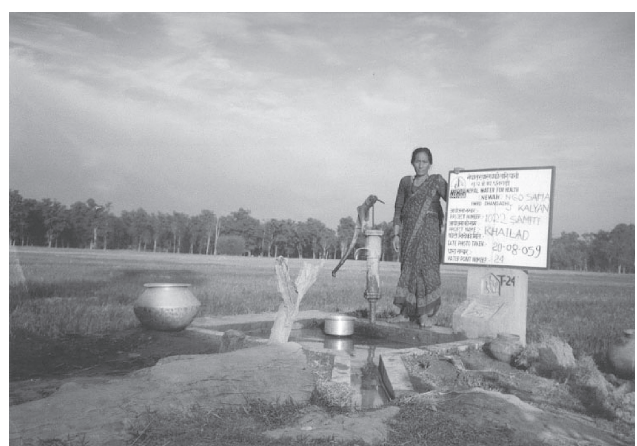
- *Photographs* of every water point, tank and source are taken with the caretaker/users holding a signboard detailing the project name, location date and the component. The photographs are converted to a digital format and a slide show of the current status of each individual project produced. These photographs are a useful complement to the questionnaires and provide those who have not visited the project site with a visual record of its current status.
