32nd WEDC International Conference, Colombo, Sri Lanka, 2006

Groundwater quality changes in the tsunami affected coastal belt – Southern Sri Lanka*Ranjana.U. K. Piyadasa, K.Weerasinghe, H. Lakmal, Sri Lanka and D. Maier, Germany*

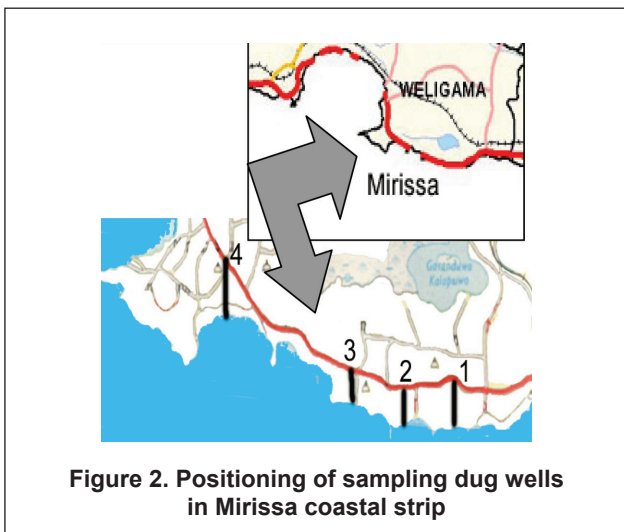
Figure 2. Positioning of sampling dug wells in Mirissa coastal strip

For the present research, a network of 19 dug wells distributed over a 5 km costal strip (Figure.2) of the tsunami-affected Mirissa area was selected. The dug wells were distributed within approx 0.5 to 0.7 km distance from the coastline covering both affected and non-affected wells. Dug Wells are selected to maintain perpendicular transects to the coastal line. The distance between two dug wells was between 50-100m. Initially, wells were selected in the vicinity of Kamburugamuwa town in a line 550 m from the coast. All the wells situated on the coast were flooded by the tsunami. Selected wells are still not used by the people for consumption. Some wells have been abandoned due to human migration. The wells selected in the third line fall in the tourist holiday bungalow area. These wells were not completely flooded by the tsunami. Here wells were constructed closer to the coastal line but elevation gradually increases as one travels inland.

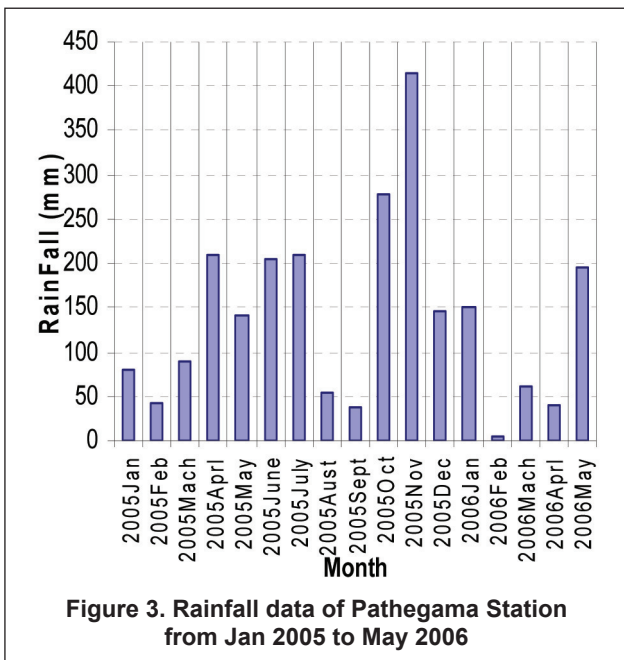
Figure 3. Rainfall data of Pathegama Station from Jan 2005 to May 2006

Precipitation data was obtained from the site of the Coconut Cultivation Board at Pategama, which is near to the study site and located about 9 km away from the study area. According to the rainfall data from January 2005 to June 2006, most of the months received more than 50 mm of rain except in Feb, Sept 2005 and Feb, April 2006. A maximum of 423 mm rainfall was received in November 2005. During the sampling period, January 2006 to June 2006, the total rainfall received by the locality was 452 mm. April - July 2005 and Oct 2005 – Jan 2006 were wet where >100 mm monthly rainfall was experienced.

Six dug wells were available in the monitoring transect and the first four of which were located 350 m from the shoreline. Last two wells are located in non affected area. In transect 1, topographically the shore line elevation gradually increases up to 6 to 8 meters. Electrical conductivity of the wells had a decreasing pattern from the coastal line to inland. It is evident that EC of well water in January 2006 was below 1000 $\mu\text{s}/\text{cm}$. This may be associated with high rainfall received during the previous months (October 2005 to January 2006, Figure 3).

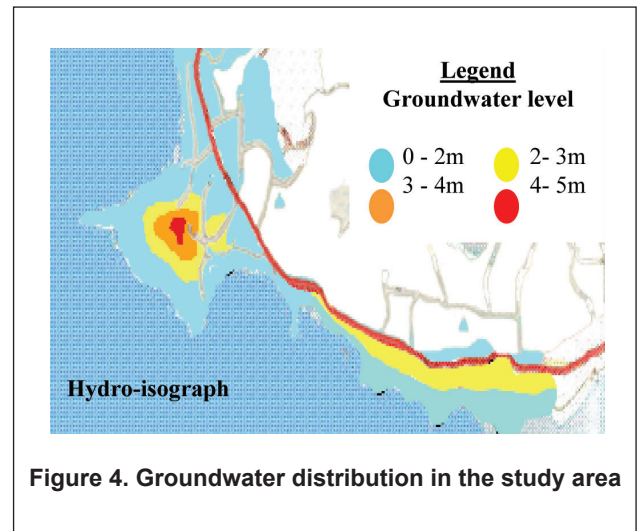
Figure 4. Groundwater distribution in the study area

It is evident from the map (Figure 4), that very shallow water levels are observed near the coastal area. However in some areas groundwater level is slightly elevated towards inland. This groundwater level behavior is affectively changing the

quality of coastal groundwater. Monitoring transects 1 and 2 had shallow groundwater levels, which fluctuated around 2 m above the mean sea level. Groundwater recharge for wells within monitoring transects 1, 2 and 3 took place from within the inland area; However, wells situated at transect 4 had no direct recharge from the inland area.

The hydraulic gradient of transects 1, 2 and 3 varies from 0.01 to 0.001 and therefore some contribution from inland areas may have added to the recharge. Therefore, hydrogeological conditions had a strong influence over the quality changes in the tsunami-affected area.

According to the groundwater distribution map, the hydraulic gradient in the transect is very low and recharge not received (figure 4). Therefore, the quality of the groundwater did not change with atmospheric precipitation.

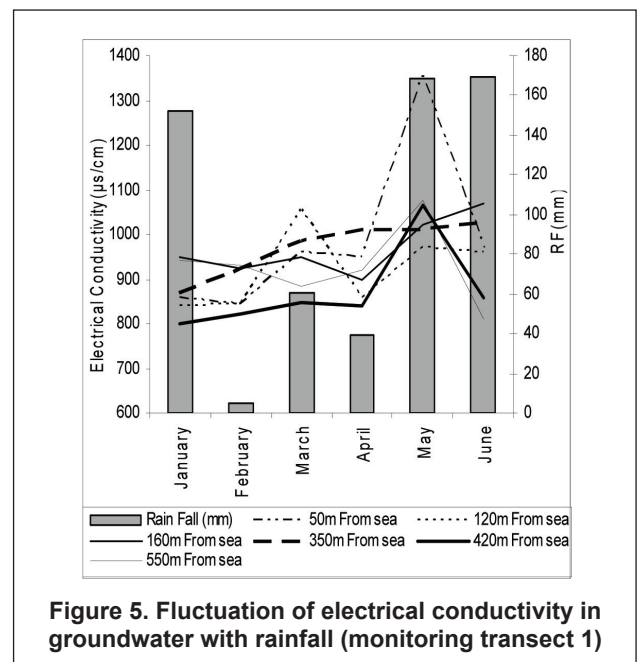
Figure 5. Fluctuation of electrical conductivity in groundwater with rainfall (monitoring transect 1)

Comparatively low rainfall (Less than 60 mm/month) received during February to April 2006 had no impact on salt accumulation in groundwater. In May, 2006, monthly rainfall constituted > 150 mm, which contributed to salt leaching from the unsaturated zone whereby increasing the EC to a maximum of 1355 $\mu\text{s}/\text{cm}$ in the coast. Analogically, other wells had EC peak up to 1000 $\mu\text{s}/\text{cm}$. However, continuous high rainfall in June 2006, appeared to dilute the salt in groundwater whereby decreasing the EC.

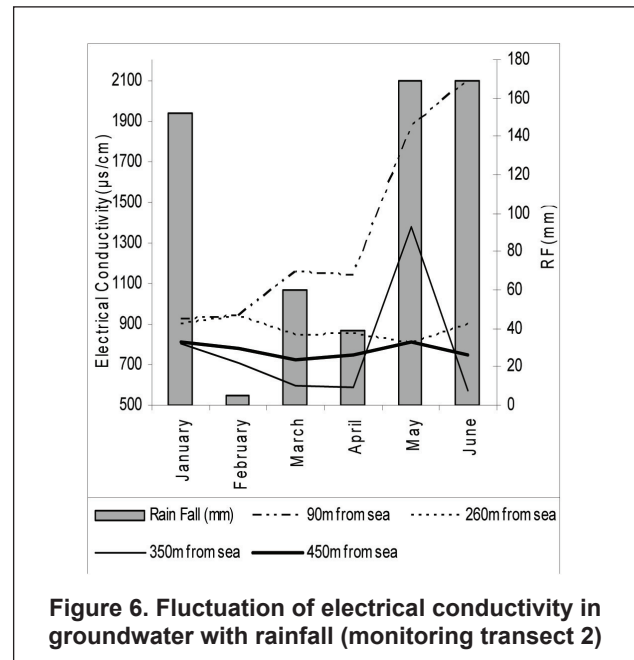
Figure 6. Fluctuation of electrical conductivity in groundwater with rainfall (monitoring transect 2)

The Second transect in Mirissa was topographically similar to transect 1. EC of groundwater fluctuated very rapidly in this transect with time and distance from 1400 to 300 $\mu\text{s}/\text{cm}$ (Figure 6). Two wells close to the shoreline in this transect were heavily affected. The last well of the selection, was located 450m from the seashore and was in the non-affected area. In the non-affected zone, mean EC values were 800 $\mu\text{s}/\text{cm}$ which remained constant through out the monitoring period.

The third well from the shoreline was located in the non-affected area, but EC values change between 270 to 1380 $\mu\text{s}/\text{cm}$. These EC value changes are the effects of the underlying saline water intrusion due to saline water flooding during the tsunami. Precipitated water received as a recharge into the wells located in the higher ground. During early February, in the first well the EC value was 900 $\mu\text{s}/\text{cm}$ due to heavy rainfall and it did not change over the month. This can be explained as precipitated water dilutes the saline water and sometimes groundwater recharge received from higher ground. Very low rainfall during February, March and April was observed and the EC values were gradually increased from 900 to 1300 $\mu\text{s}/\text{cm}$. This was due to low rainfall during this period and the groundwater recharge rates were low from higher ground. Sometimes due to low rainfall evapotranspiration

rates are high. Therefore, saline water intrusion is high and saline water which drains into the aquifers was high. Due to high rainfall during June, salinity levels were increased up to 2100 $\mu\text{s}/\text{cm}$. Salinity levels changed rapidly in the second and third wells in the considered line compared to the first well. This means that the quality of water changed due to precipitation and groundwater recharge.

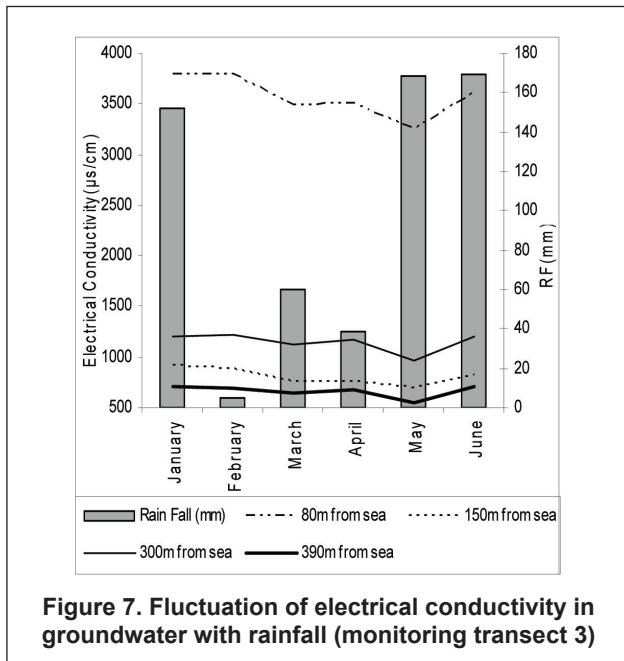
Figure 7. Fluctuation of electrical conductivity in groundwater with rainfall (monitoring transect 3)

The first well of the transect was highly affected by the tsunami and located 80 m from the shoreline. Just after the tsunami, several attempts were made to pump the wells clean. This may have aggravated the situation due to internal seepage from sea to land and as such the EC value in January 2006 remained at a high level of 3880 $\mu\text{s}/\text{cm}$. As evident from the data, the EC values have not changed due to precipitation. Throughout the monitoring period, EC values ranged between 3880 and 3250 $\mu\text{s}/\text{cm}$. This may be related to up-coning of underlying saline water draining into the well due to exclusive pumping. (This well was located in the tourist bungalow premises and according to the information given by the owner, before the tsunami well water was used for domestic purposes).

The second and third wells were located 150 and 300 m away from the shoreline and slightly affected by the tsunami. EC values of the two wells were around 1000 $\mu\text{s}/\text{cm}$, which decreased with high rainfall and increased with low rainfall. However, in all the affected wells EC values remained over 2000 $\mu\text{s}/\text{cm}$ level. However with low rainfall the EC values were increased up to 3000 $\mu\text{s}/\text{cm}$. Therefore in this transect, the quality of groundwater depends only on atmospheric precipitation. According to the hydrogeological map hydraulic

gradient does not change. Therefore, quality of water does not change due to groundwater recharge. EC values in the affected dug wells change in the range 1860 to 1420 $\mu\text{s}/\text{cm}$. According to the information collected during the study period non-affected groundwater used for domestic purposes are not suitable for drinking at present.

The last well of the transect was located at a higher elevation (above 8 m) and not affected by the tsunami and the EC values fluctuated within 700-500 $\mu\text{s}/\text{cm}$.

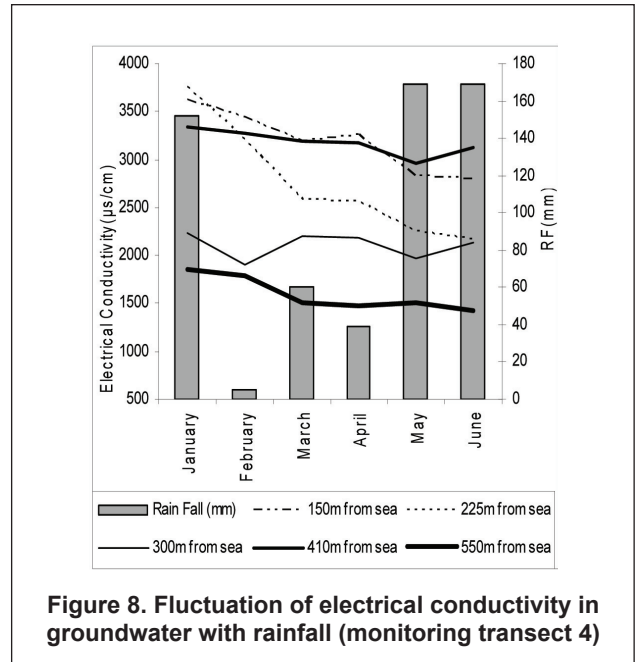
Figure 8. Fluctuation of electrical conductivity in groundwater with rainfall (monitoring transect 4)

Transect four is different from the other three transects because the dug wells are located on flat land. The elevation is around 2m from M. S. L. throughout the transect. The first four wells in the transect were located in the tsunami affected zone and the last well was in the unaffected zone. The length of the transect is 550m from the shoreline (Figure 8). Well water in the affected wells changed in the range 4000 to 2000 $\mu\text{s}/\text{cm}$ and unaffected well water EC is below 2000 $\mu\text{s}/\text{cm}$.

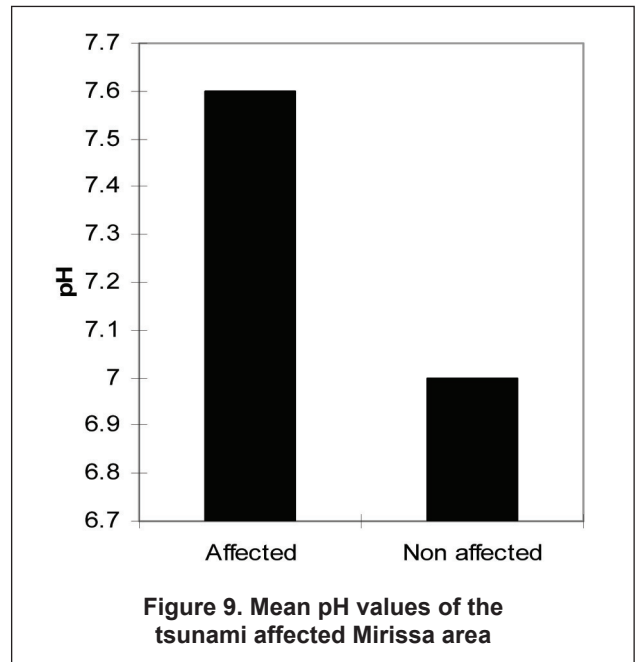
Figure 9. Mean pH values of the tsunami affected Mirissa area

According to the pH Values of the groundwater in the transects, the affected and non-affected areas can be separated noticeably (Figure 9). The pH of water in affected wells was between 7 and 8 and with the rainfall it has changed. The pH values of the wells in non-affected area were around 7. During the high rainfall period, pH values changed noticeably. After May, pH values changed significantly to be below 7 due to high rainfall. This can be explain as the

continued recharge received fresh groundwater from high plains diluting the well water.

The pH values do not changing in the non-affected area with rainfall, but in the affected areas, pH values changed considerably. In affected areas, mean pH value is 7.6 while it is around 7 in non-affected areas.
