35th WEDC International Conference, Loughborough, UK, 2011

**Monitoring of drinking water distribution system by
SCADA in Antalya City, Turkey**

BRIEFING PAPER 1113

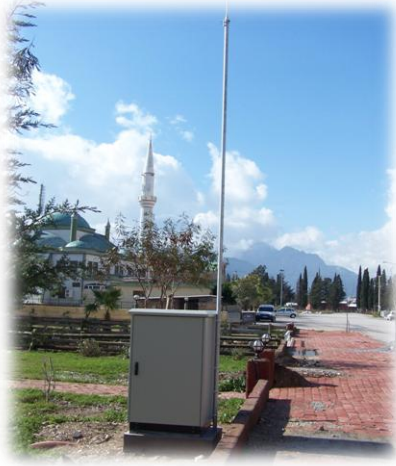
Photograph 1. A typical view of a SCADA station located along a water main in Antalya City

Antalya drinking water supply system has been recently equipped with more than 90 stations for the continuous on-line monitoring of water quality and quantity. The stations are located on the groundwater wells, spring water, water reservoirs, pumping stations and at many locations along the water distribution main pipes. The stations are equipped with sensors for the on-line measurements of water temperature, pH, conductivity, turbidity, free residual chlorine, water flow rate, water pressure and water levels in the distribution reservoirs beside energy consumption. The total cost of the SCADA system is around five million Euros. One of the SCADA stations and the on-line measurement sensors are illustrated in Photograph 1. and Photograph 2. The monitored parameters are wirelessly sent to the SCADA (Supervisory Control And Data Acquisition) center located at the main building of Antalya Water and Wastewater Administration (ASAT). These parameters are displayed on large screens located in the SCADA center and also stored for further analyses in the future.

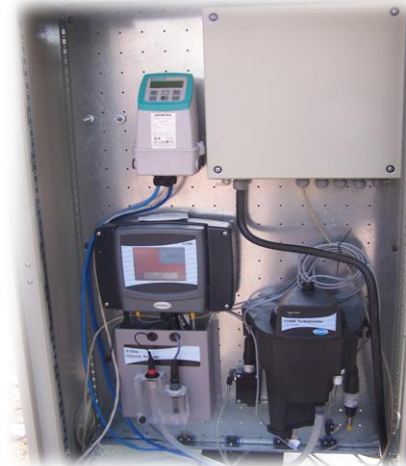
Photograph 2. On-line measurement sensors for temperature, pH, turbidity, electrical conductivity and free residual chlorine

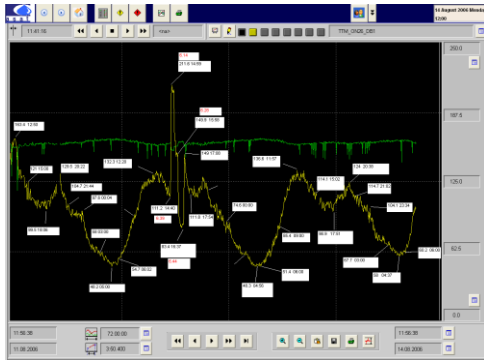
Photograph 3. SCADA flow rate after a breakdown in one of the water distribution pipes

SCADA system helped in quick detection of pipe bursts due to the abnormal increase in flow rates which is easily detected on-line as shown in Photograph 3. It is worth to mention here that the leaked water usually does not appear on ground surface due to the karstic characteristics of Antalya City which implies difficulties in detecting pipe bursts.

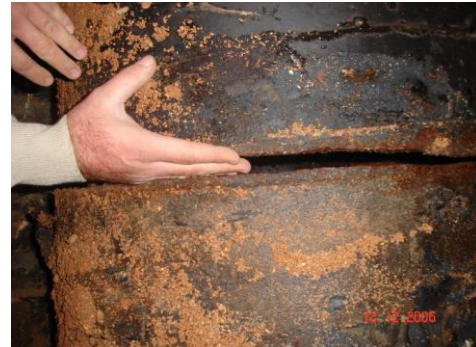
Photograph 4. Crack in the inlet pipe to Caglayan water reservoir in Antalya City detected by carrying out water budget

Monitoring the water flow rates entering to the reservoirs beside the water level in the reservoirs prevented the overflow from reservoirs and helped in detecting leakages in the reservoirs by checking the water budget. For example, the data sets supplied by the SCADA station at *Çaglayan* water distribution reservoir

(15000 m³ storage capacity) showed that there was a water leakage of 100 m³/hour originated from a serious crack in the inlet pipe of the reservoir as depicted in Photograph 4.

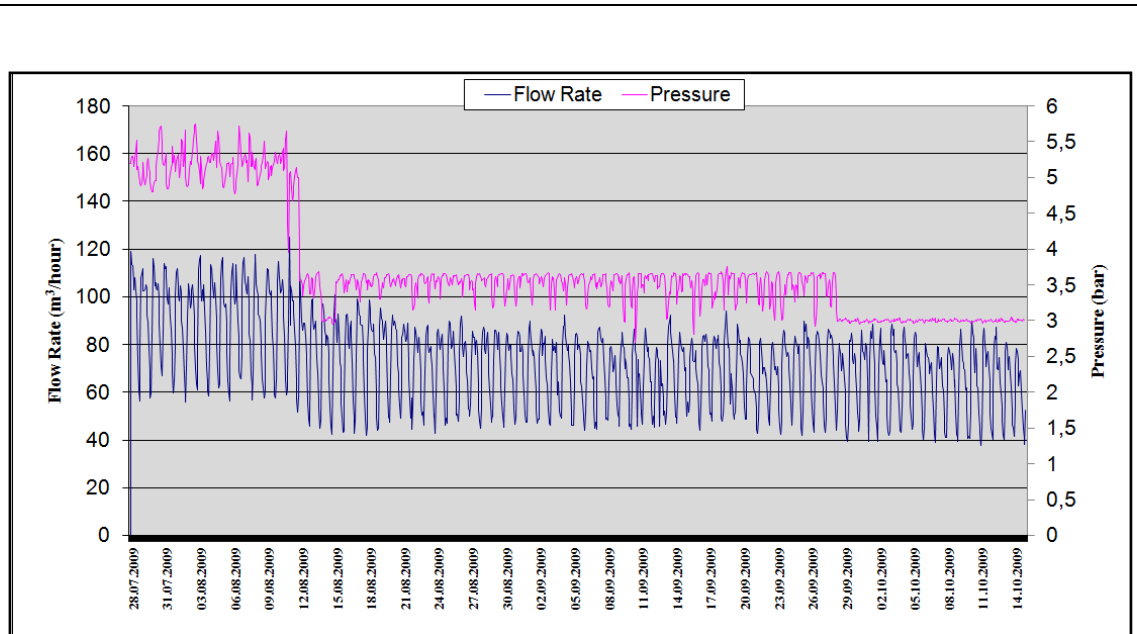
Figure 1. Reduction of water pressure from 5.5 bars to 3.0 bars at Vestel/ DMA

Water pressures were analyzed during different water consumption rates and the excess pressure values were reduced using pressure release valves (PRV) to reduce physical water losses as recommended by many researchers (Reis and Chaudhry, 1999; Thornton and Lambert 2006). For example, water pressure was reduced from 5.5 bar to 3.0 bar by using PRV at the DMA called *Vestel*. This resulted in reducing physical water losses to considerable values as determined by the SCADA system and shown in Figure 1. The level of pressure reduction up to 3.0 bars was chosen by applying the USA-EPA EPANET hydraulic model (TUBITAK, 2009). Consequently, no complains were received from the customers. As a result, ASAT plans to apply pressure management in the other areas of Antalya city which exhibit excessive water pressure.
